## Archaeological Trenched Evaluation Report:

On Land North of Bronwylfa Road,  
Rhostyllen, Wrexham.

November 2023

Report No. 2241

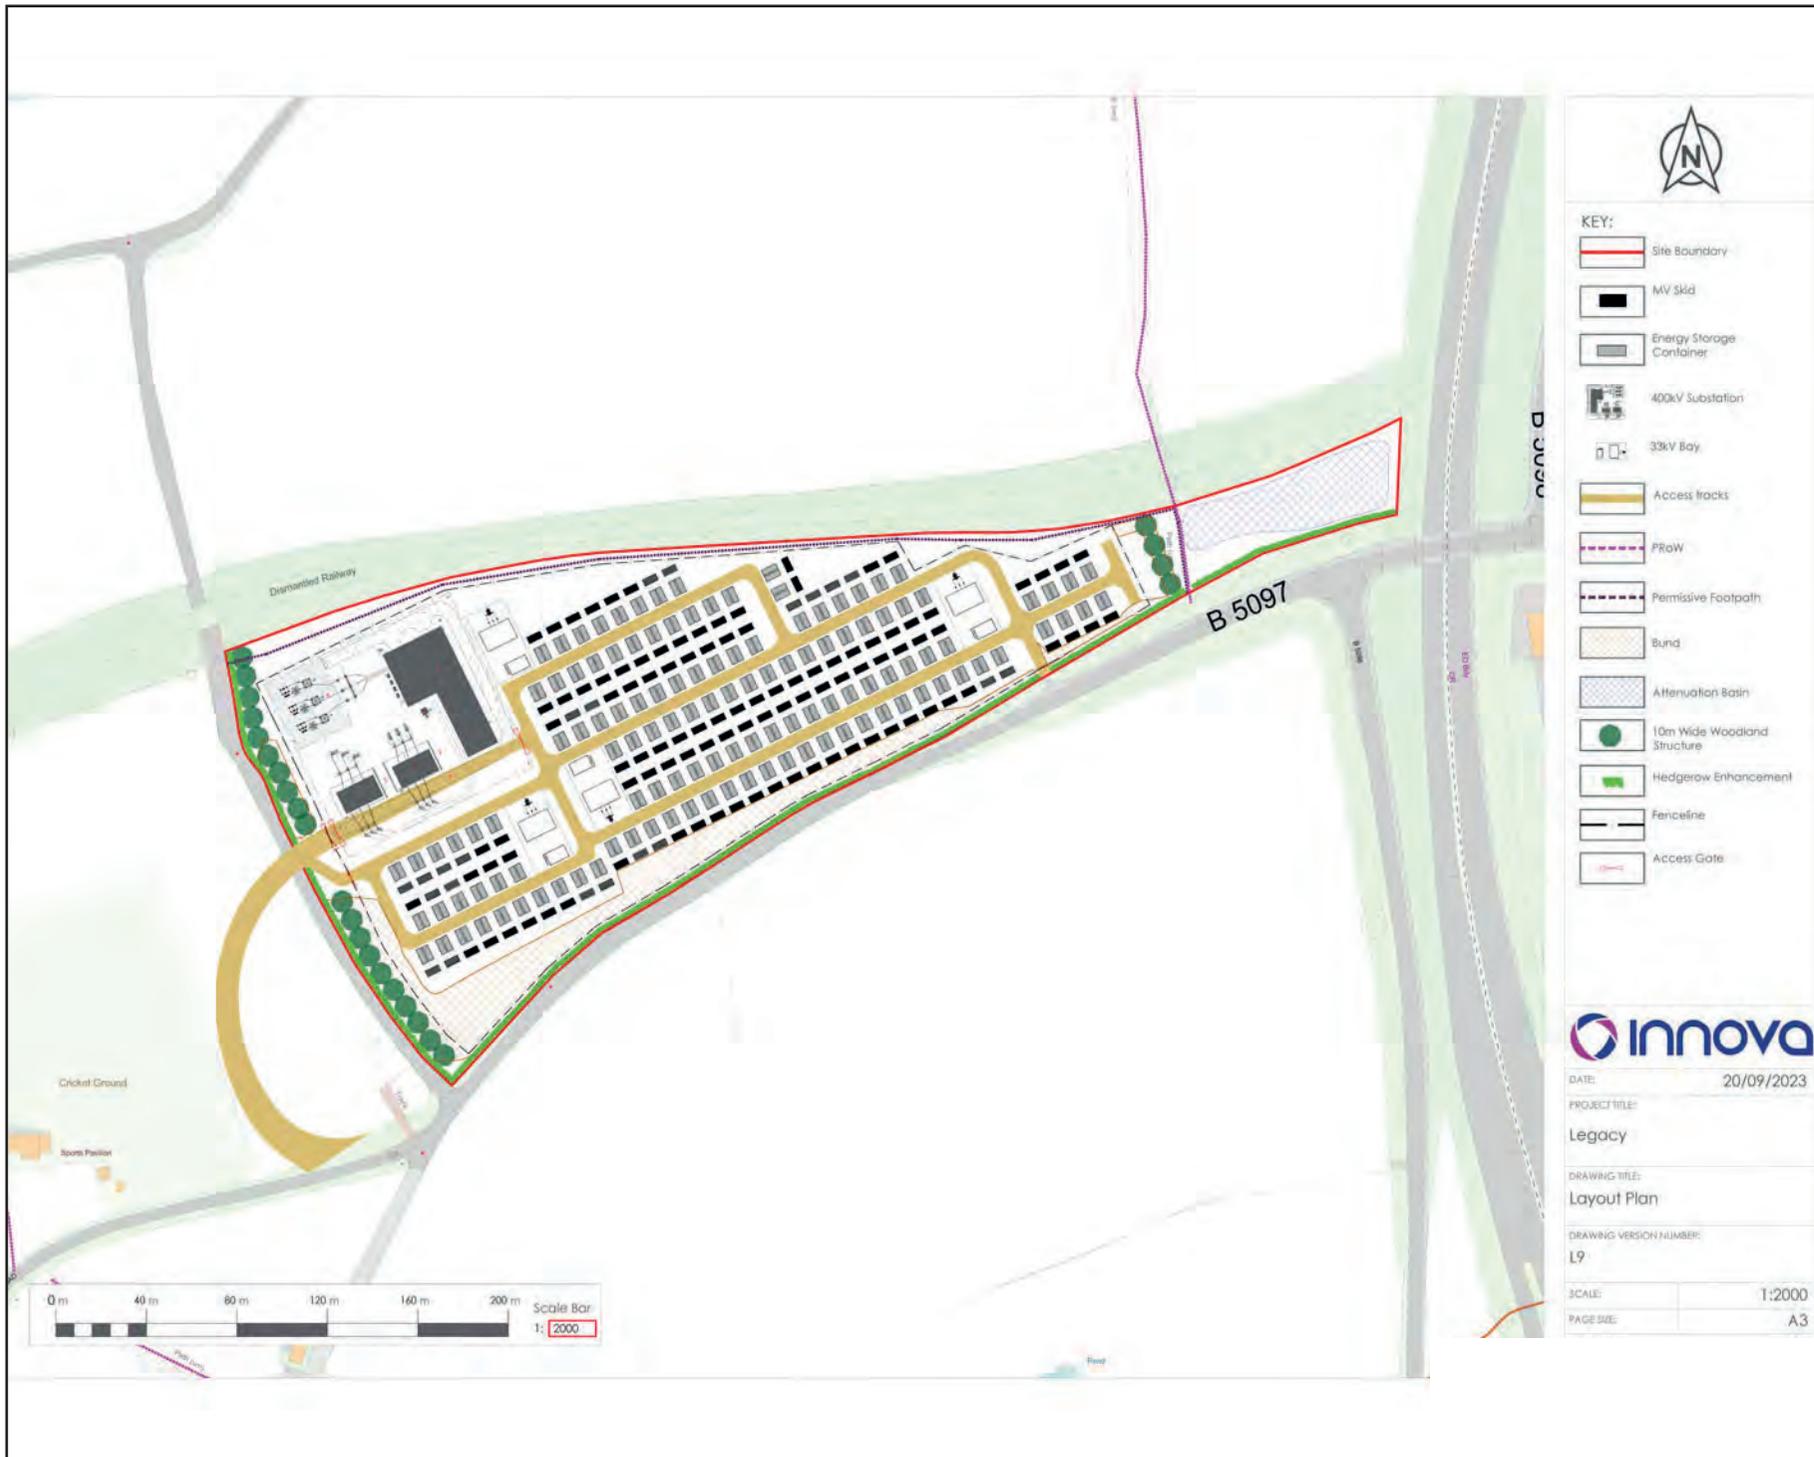
Figure 2: Proposed Development Plan

- 2.2.1 Installation and operation of an Energy Storage System (ESS) including energy storage units, substation, site access, cable connection, landscaping and ancillary infrastructure.

- 2.2.3 The Energy Storage units will be laid out in rows with intervening access areas. The units will sit on concrete slabs or supporting feet. Internal access tracks will comprise crushed stone and the access road for the abnormal load will be asphalt. The Energy Storage units will use LFP (Lithium Iron Phosphate) technology and measure approximately 2.9m in height. The GIS building in the substation area will measure approximately 14m in height and is therefore the tallest piece of equipment.

- 2.2.4 The associated MV skids are sited alongside the Energy Storage units and connect in groups to 33kV transformer bays distributed evenly throughout the site. The substation compound is proposed to be located on the north-western corner of the site.

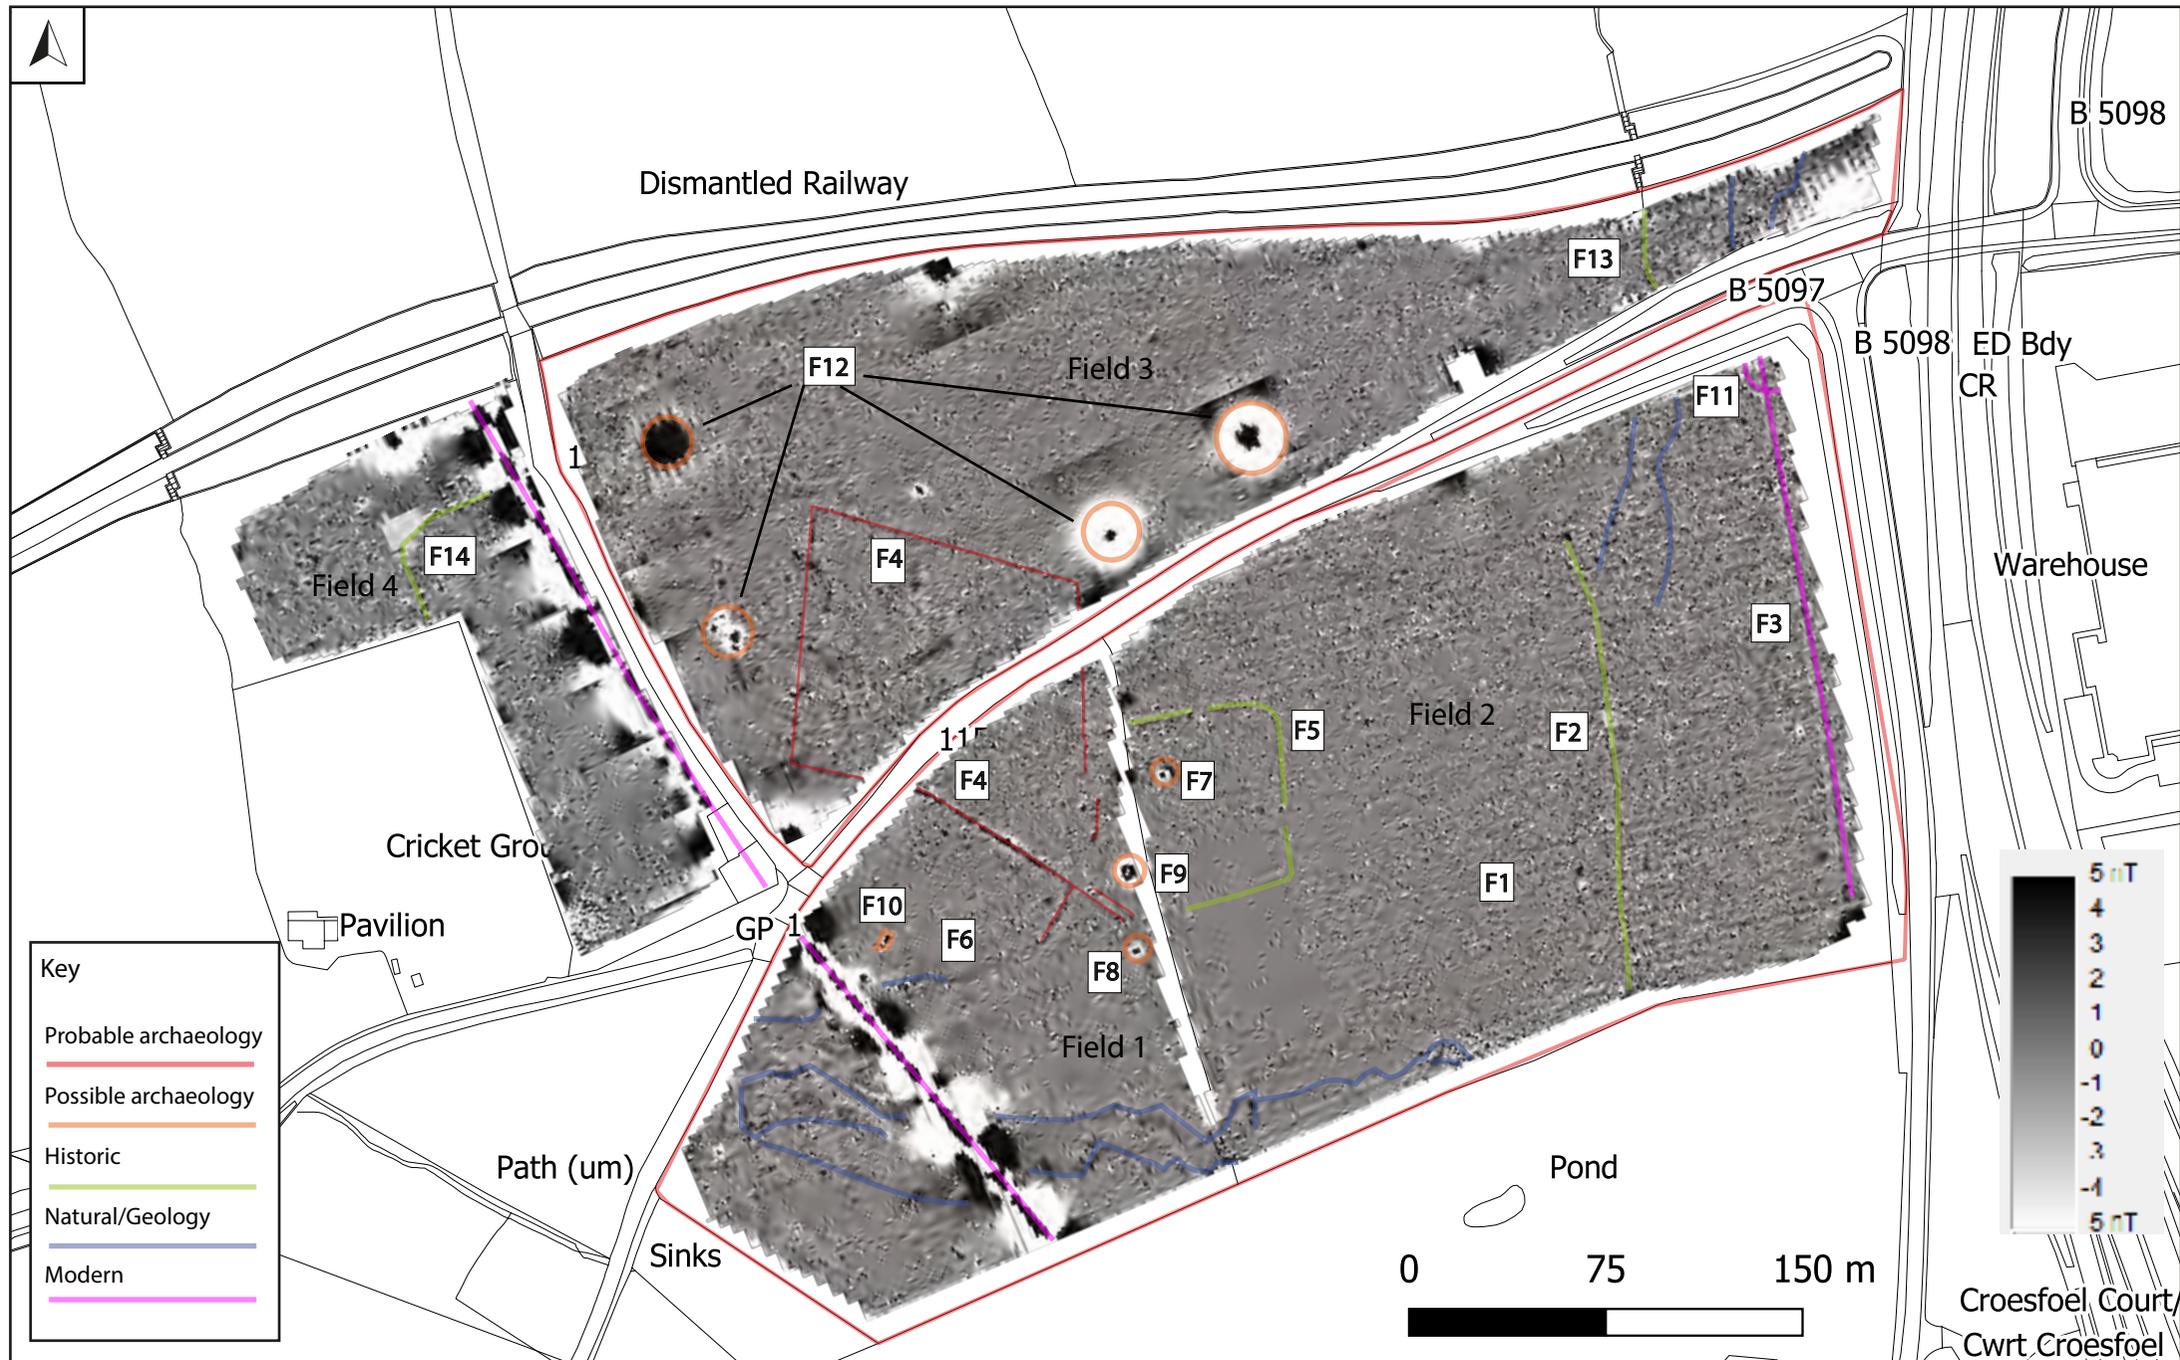
Figure 5. Fields 1-4: Grayscale plot of processed data clipped to +/-5 and destripped, with interpretation

- 2.3.5 There are five listed buildings within close proximity to the development site.
- 2.3.6 A geophysical Survey was carried out by AW in May of 2023 which identified a number of anomalies characteristic of archaeological features. These included field boundaries which are visible on 19<sup>th</sup> century mapping, however many of these features have been interpreted to represent former field boundaries which pre-date the 1839 tithe map. The geophysical results also indicated that one or more pits may be present in the vicinity of these field boundaries. Field 3 of the

geophysical survey contained four possible larger circular or elliptical anomalies which could represent former open cast coal (bell) pits (Muller 2023).

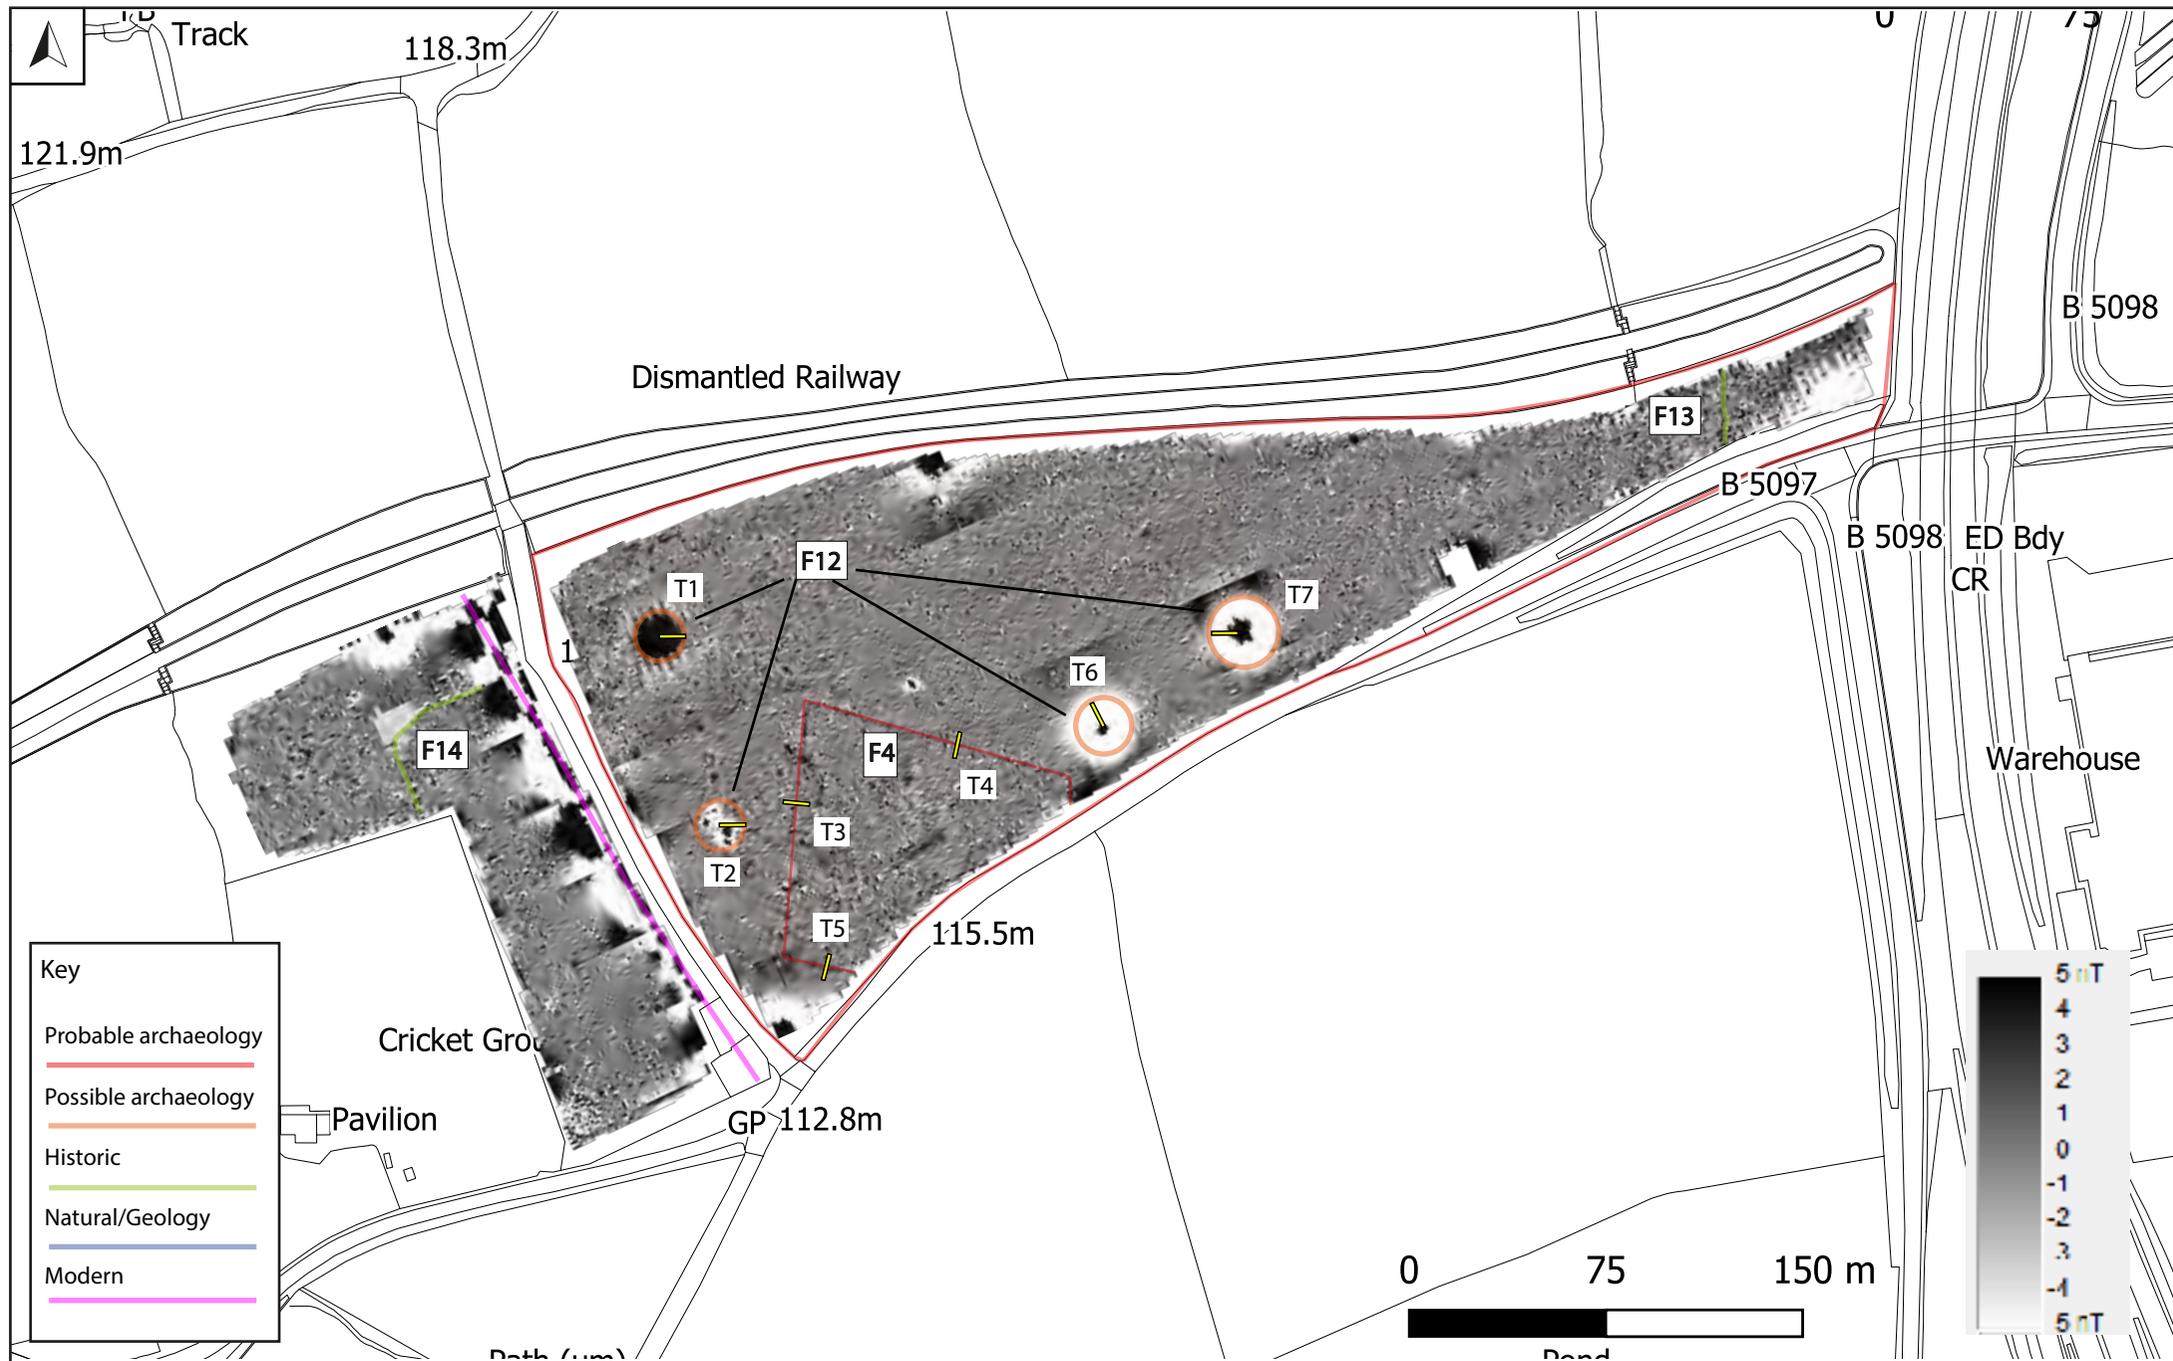
Figure 4. Proposed Trench Plan with Geophysical Survey Results and Interpretation

- 1.1.2 Consultation with CPAT-APM dated 13/12/2022 confirmed the requirement for an archaeological Geophysical survey to be submitted in support of the application at the pre-determination stage in the Energy Storage System areas to test for unrecorded sub-surface archaeology. Following the results of the survey the client confirmed that only the northern part of the area would be subject to the planning application. Upon further consultation with CPAT-APM dated the 10-11/5/2023 a plan of seven 10m x 1.8m trenches targeting specific geophysical anomalies was agreed (Figure 4).

4.1.1 The evaluation consisted of seven 10m x 1.8m machine dug trenches that targeted possible archaeological features identified in the geophysical survey (Muller 2023).

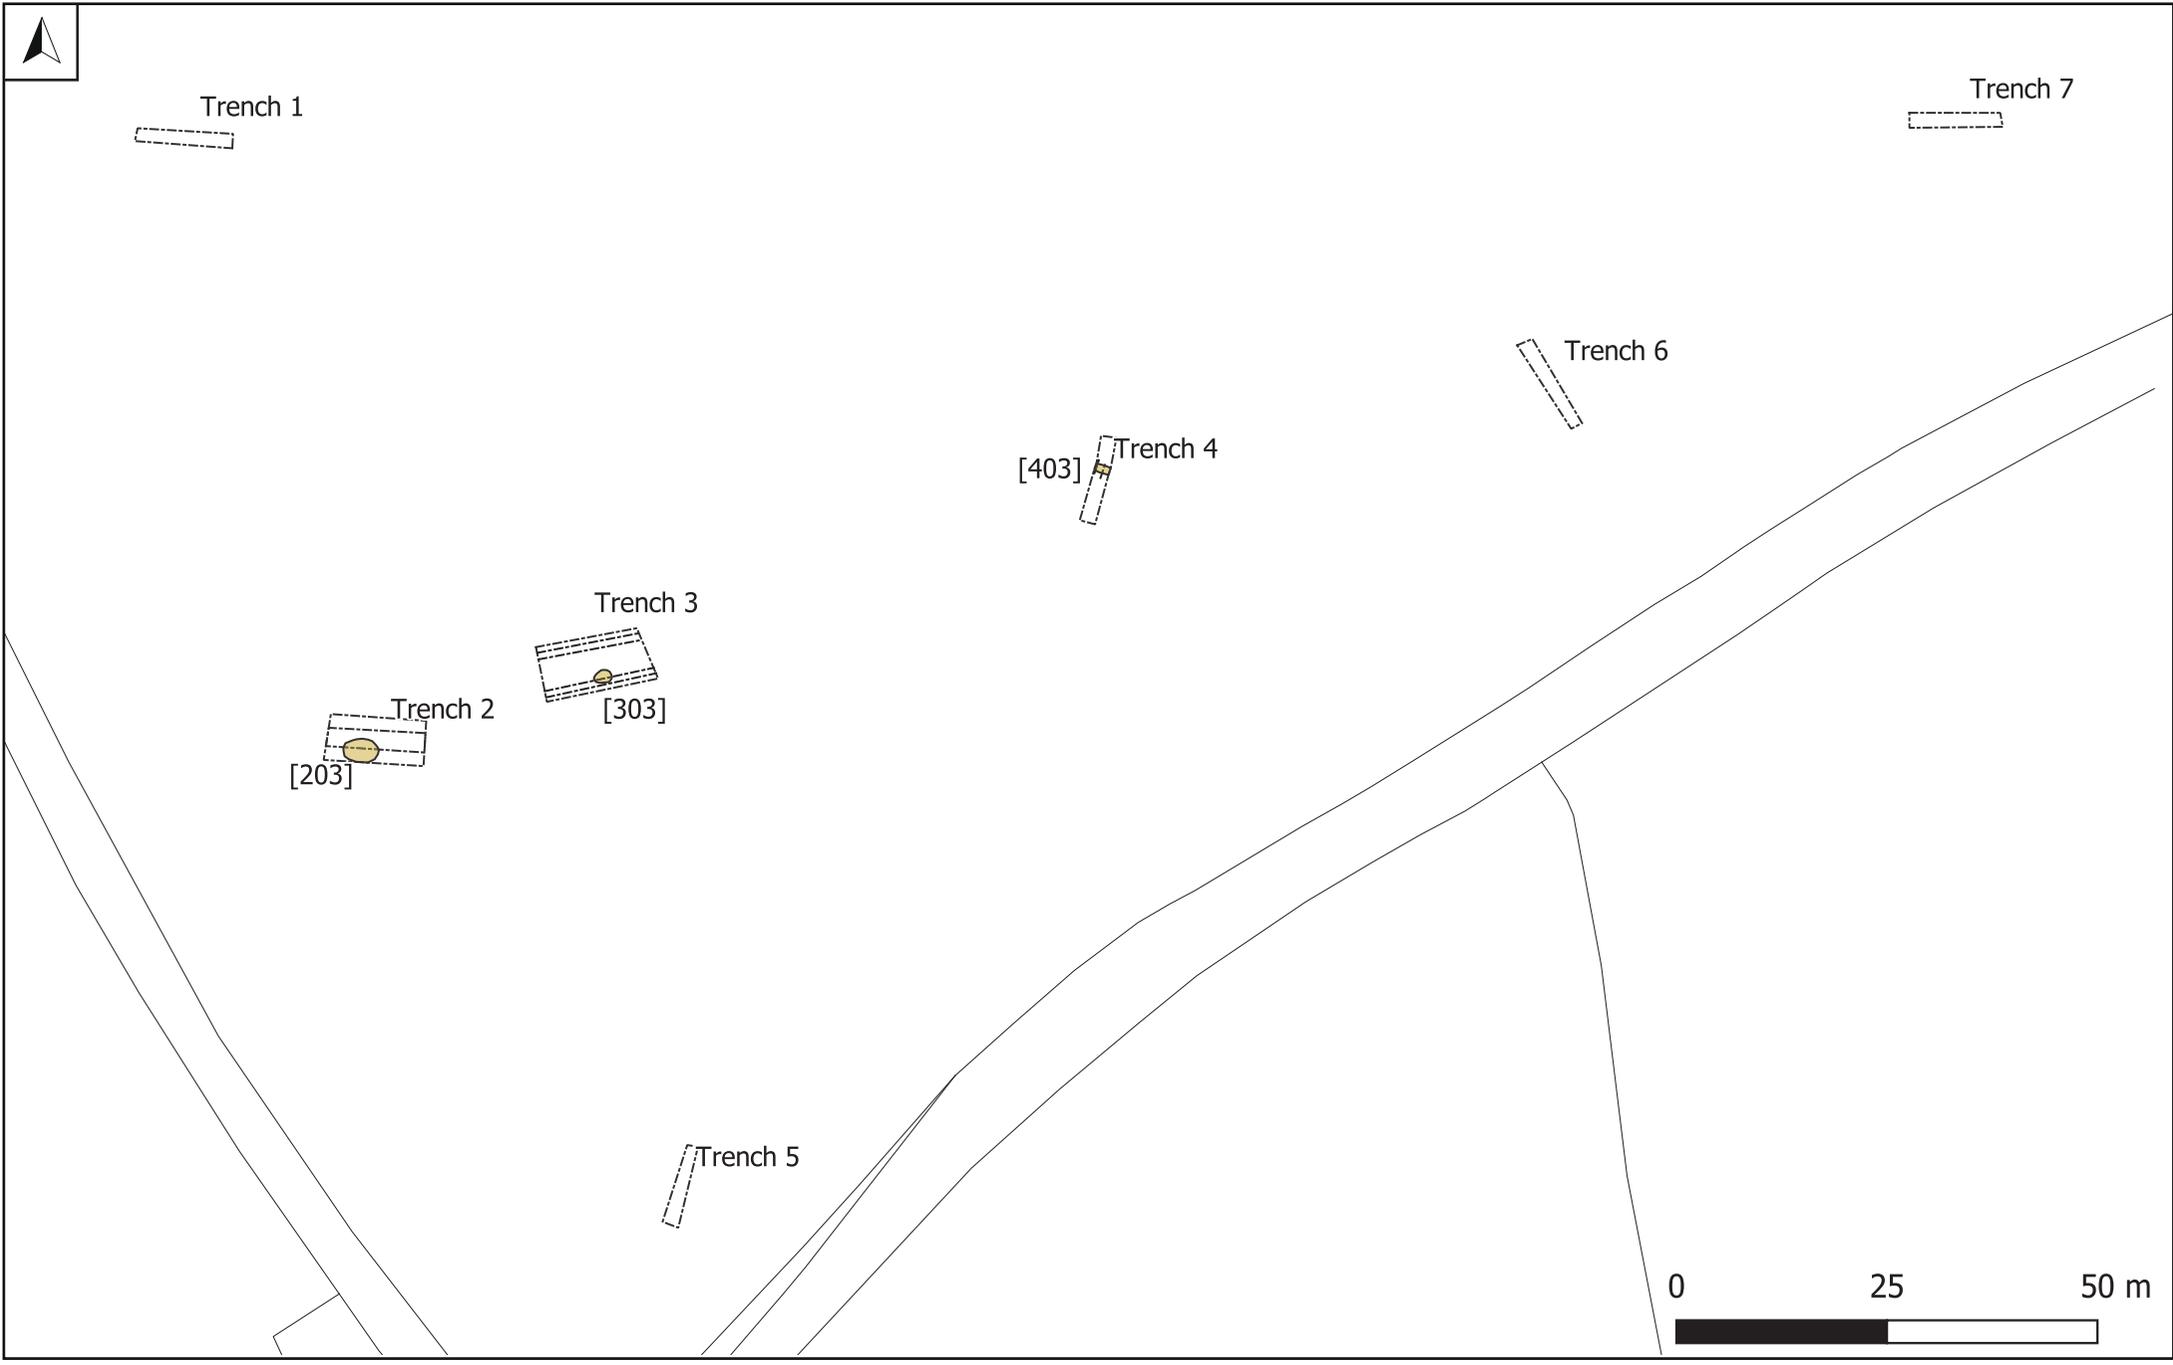
Figure 5. Trench Excavation Plan

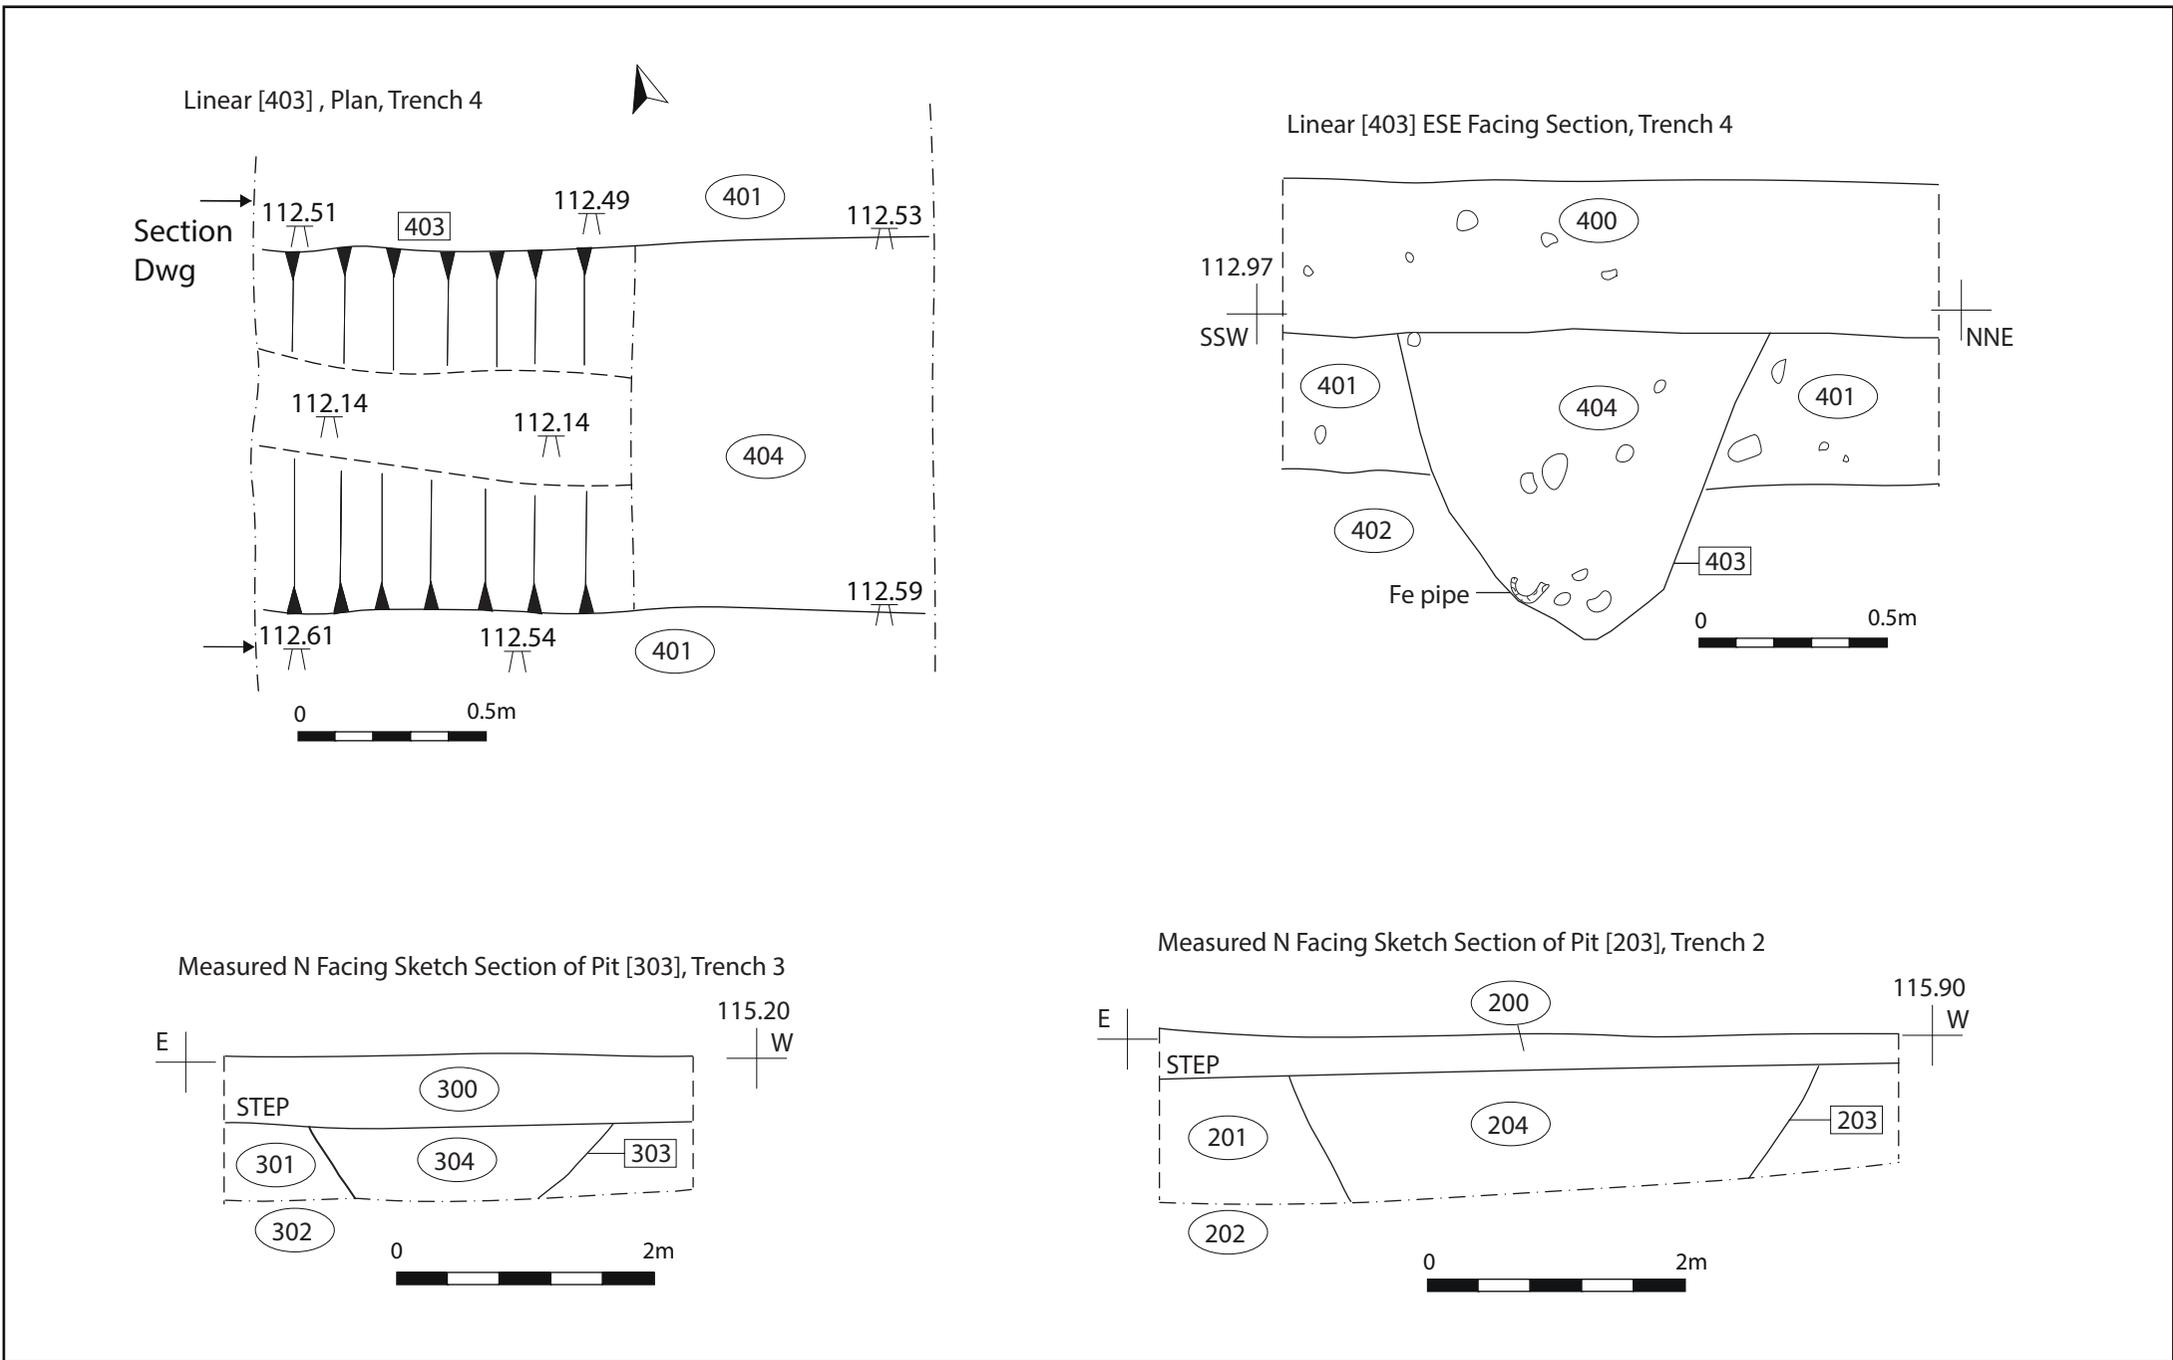
Figure 6. Detailed Plans and Sections

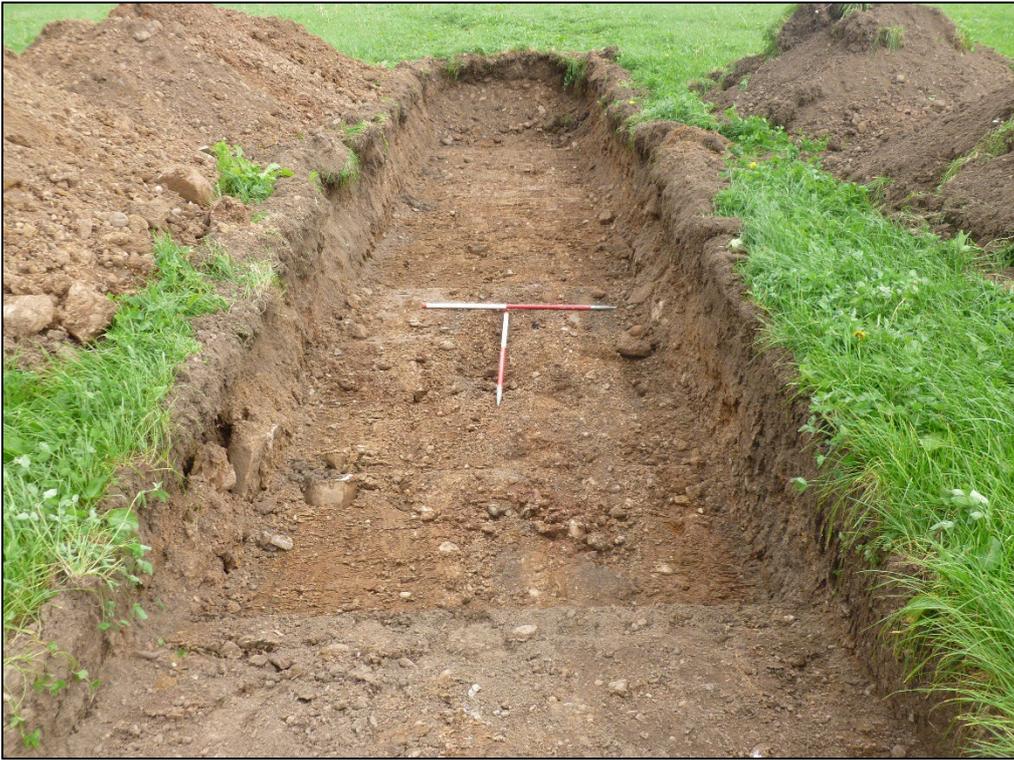
*Plate 1: Trench 1, fully excavated, view to the West. 2x1m scale.*

4.2.1 Trench 1 measured 10m long by 1.8m wide and was excavated to a maximum depth of 0.75m. It was orientated E-W and located within the northwestern corner of the site in order to test one of the dipolar magnetic responses comprising geophysical anomaly F12.

4.2.2 The basal deposit (102) was interpreted as natural geological layer. It comprised a mid-reddish brown sandy silt with inclusions of frequent gravel and sandstone. The deposit was encountered at a depth of 0.55m below ground level and had an exposed thickness of 0.2m. Deposit (102) was overlaid by subsoil layer (101).

4.2.3 Layer (101) comprised a mid-reddish brown sandy silt subsoil containing inclusions of moderately frequent rounded and subangular sandstone. The deposit was encountered at a depth of 0.3m below ground level and had an exposed thickness of 0.25m. Subsoil (101) was overlaid by topsoil layer (100).

4.2.4 Layer (100) was a mid-greyish brown sandy silt topsoil with. The deposit had a maximum thickness of 0.3m.

4.2.5 The trench was devoid of any significant archaeological finds, features, or deposits.

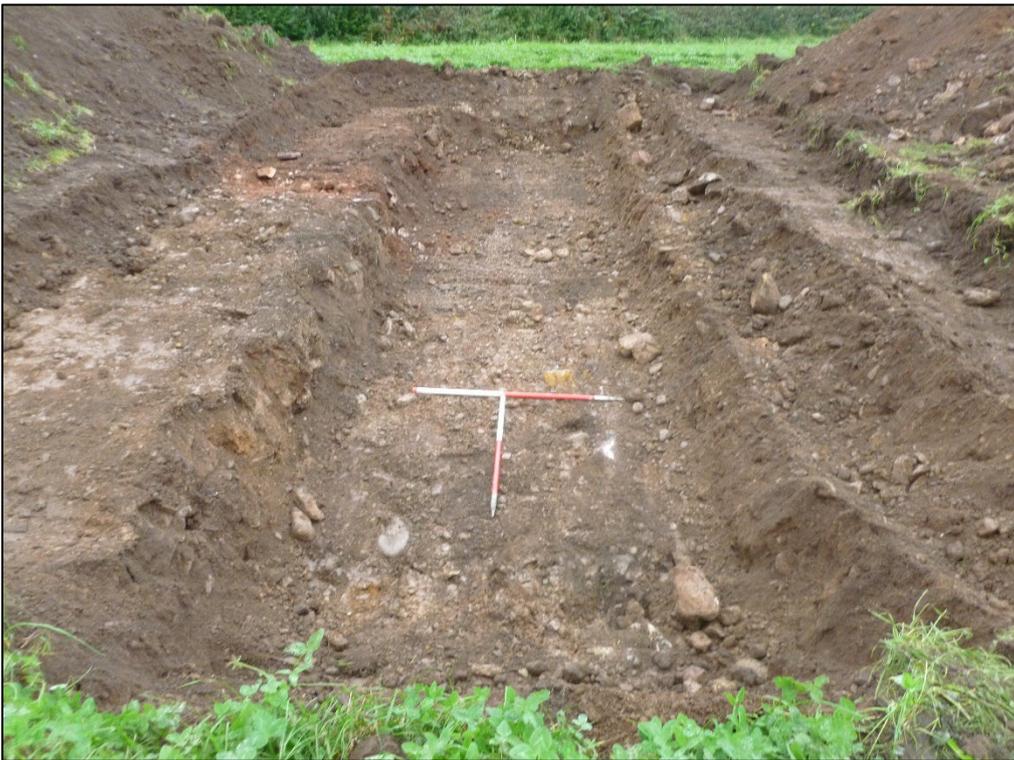
*Plate 2: Trench 2, fully excavated, view to the west. 2x1m scale.*

4.3.1 Trench 2 measured 10m long, was stepped to a width of 5.65m and was excavated to a maximum depth of 1.2m. It was E-W orientated and located towards the

western boundary of the site, in order to test one of the dipolar magnetic responses comprising geophysical anomaly F12.

- 4.3.2 Basal deposit (202) was interpreted as a natural geological layer. It comprised a light greyish brown sand and gravel. The layer was encountered at a depth of 1m below ground level and had an exposed thickness of 0.2m. Deposit (202) was overlaid by layer (201).

- 4.3.3 Layer (201) comprised mixed stone, sandstones, gravels and slate interpreted to be a loose re-deposited layer. It was encountered at a depth of 0.25m below ground level and measured more than 6m in length, 1.8m in width and had a maximum thickness of 0.75m. Deposit (201) appeared to be cut by pit [203].

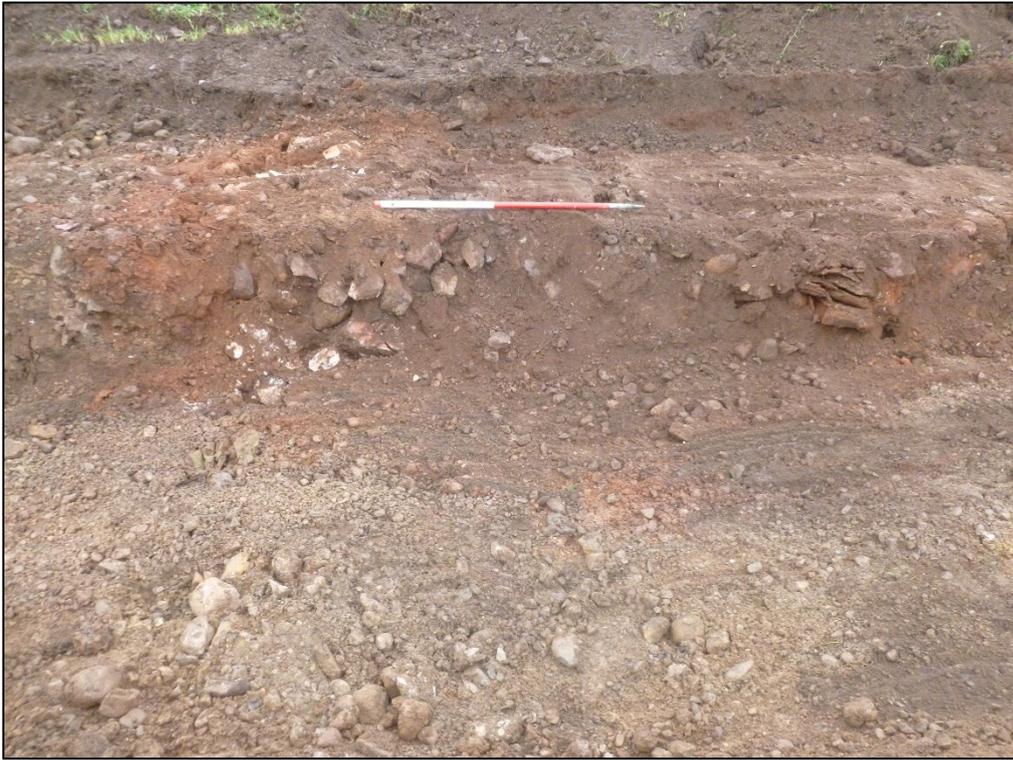
*Plate 3: North facing section of pit [203] showing fill (204), view to the South. 1m scale.*

- 4.3.4 Pit [203] was apparently cut into deposit (201). It was located towards the south western corner of the trench and was roughly ovular in plan and orientated approximately E-W, it had moderately sloping and symmetrical sides and an assumed concave base. It measured 4m in length and 2m in width with a depth of 0.75m as excavated. The pit was filled by deposit (204).

- 4.3.5 Fill (204) comprised a mixed orangey red sand of a loose compaction containing large rounded and subangular sandstone inclusions and some degraded orange sandstone around the edge. It had a length of 4m and a width of 2m and had a maximum thickness of 0.75m. It contained no dateable finds. Pit [203]/(204) is tentatively interpreted as a cobble filled circular feature with a redder colouration to the fill around the edge. Due to the loose rubbly nature of the fill and the depth of the trench it was not possible to enter the trench safely and clean up the sections, however it does appear to correspond with one of the dipolar magnetic responses comprising geophysical anomaly F12, possible bell-pit. Deposit (204) was overlain by topsoil (200).

- Pit [203] within Trench 2 corresponds with one of the di-polar geophysical anomalies (F12) and is tentatively interpreted as a possible 'bell pit'. Unfortunately, the nature of the fill and the layer (201) into which it appeared to be cut were very loose and unstable and it was not possible to safely enter the trench to excavate or clean up the sections any further. Caveats must therefore remain to its interpretation as a former 'bell pit'. Firstly, neither the backfill of the pit (204), nor the loose layer (201) surrounding it contained any evidence of former coal working waste as would be expected associated with a bell pit. Secondly, the loose nature of the surrounding material would have presented serious safety issues in its original excavation. And use. It is possible that loose material (201) represents the upcast mound from the excavation of the pit, and that lower down, the shaft was cut into more stable material. Nevertheless, the presence of coal waste would be expected in both layers (201) and (204) if that was the case.

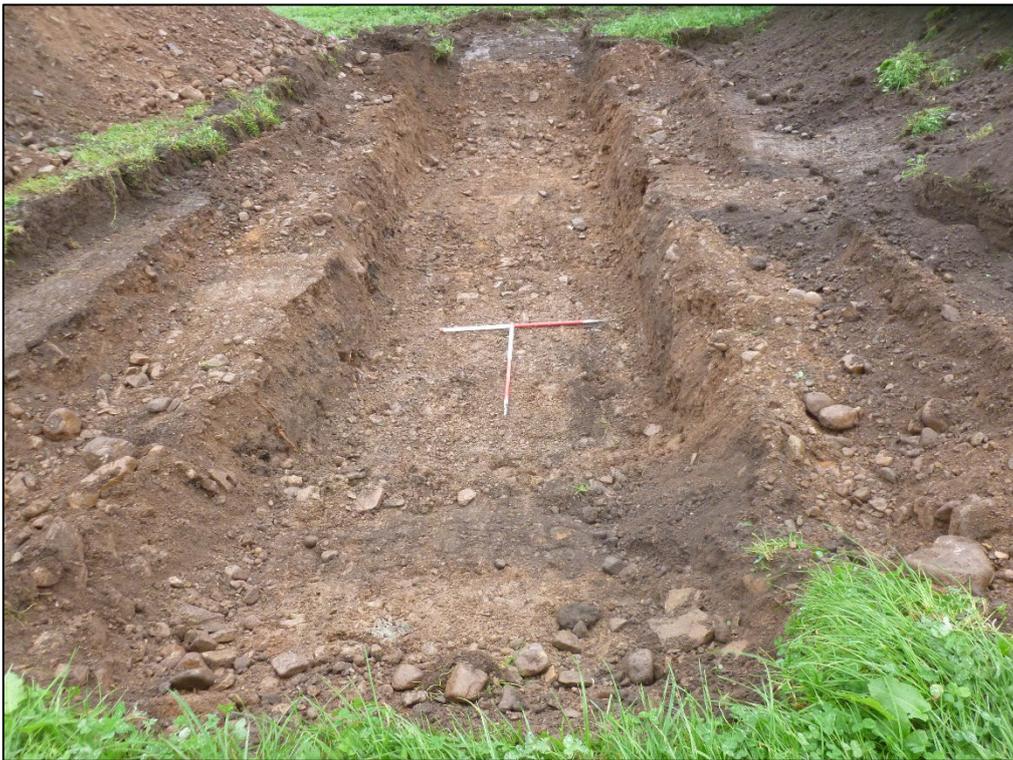
*Plate 4: Trench 3 fully excavated, view to the east. 2x1m scale.*

- 4.4.1 Trench 3 measured 10m long, was stepped to a width of 3.8m, and excavated to a maximum depth of 1.2m. It was E-W orientated and located to the east of Trench 2, in order to test one of the linear magnetic responses comprising geophysical anomaly F4.
- 4.4.2 Basal deposit (302) was interpreted as a natural geological layer. It comprised gravels and frequent subangular and rounded sandstone and ironstone. The deposit was encountered at a depth of 1.2m below ground level. Natural layer (302) was overlain by subsoil (301).
- 4.4.3 Layer (301) comprised a mid-reddish brown sandy silt subsoil containing moderate inclusions of rounded and subangular sandstone. It was encountered

at a depth of 0.5m below ground level and had an exposed thickness of 0.7m. Subsoil (301) was cut by pit [303].

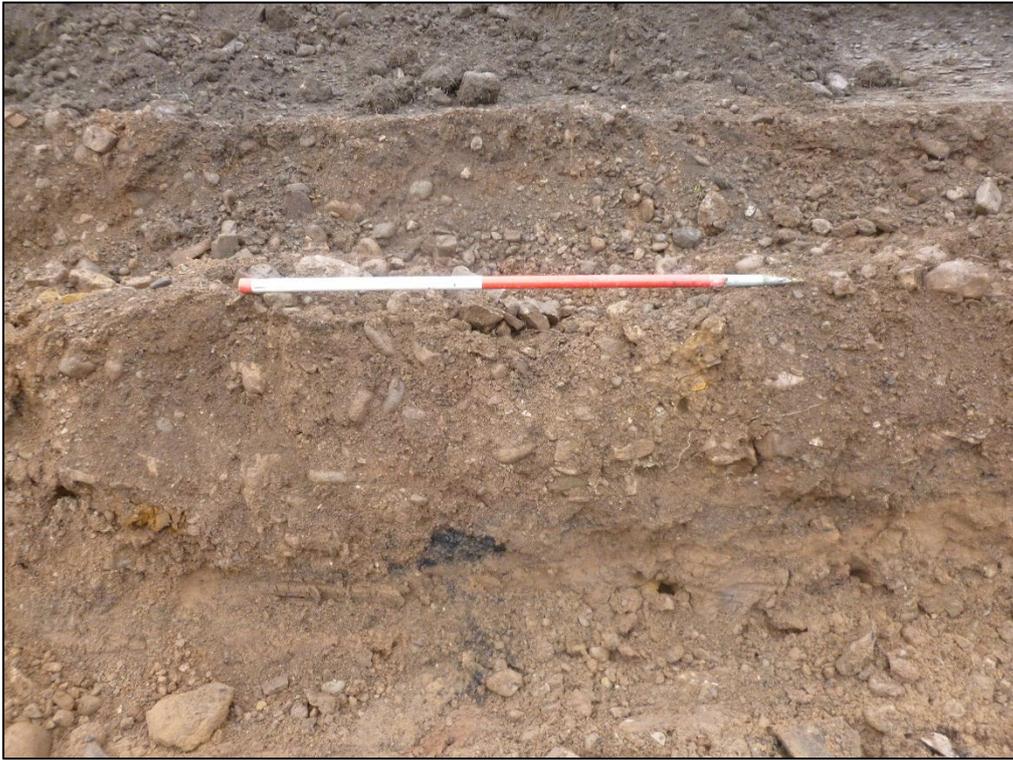
*Plate 5: North facing section of pit [303], showing fill (304), view to the South. 1m scale.*

4.4.4 Pit [303] was located towards the southeastern corner of the trench. It was subcircular in plan and continued beyond the limit of excavation. It had a symmetrical profile with moderately sloping sides and a concave base. It measured 2m in length and 0.9m wide and had a maximum depth of 0.7m. The pit was filled by deposit (304).

4.4.5 Fill (304) comprised a light orangey yellow sand and mid greyish brown sandy silt of a very loose compaction containing rare inclusions of small sandstone and infrequent black carbon deposits, possibly representing degraded coal, but no dateable finds. Due to the loose rubbly nature of the fill and the depth of the trench it was not possible to enter the trench safely and clean up the sections, however its position does appear to correspond with one of the magnetic responses comprising geophysical anomaly F4. However, F4 had previously interpreted as a linear comprising the western arm of a possible enclosure. The excavated evidence from Trench 3 rather indicates that this putative linear is more correctly an amalgamation of discrete feature [303] and natural geological magnetic variations. Deposit (304) was overlain by deposit (300).

- Pit [303] in Trench 3 did contain some black carbon rich material within its fill (304). Again, the loose nature of the trench edges did not allow for any further safe excavation in this trench. Nevertheless, pit [303] is tentatively interpreted as a possible bell pit. Trench 3 had been located over a possible linear geophysical anomaly thought to be associated with possible ditched enclosure (F4). Anomaly F4 was tested in three trenches (Trenches 3, 4 and 5) in which the anomalies were revealed to comprise a discrete feature [303], a modern linear [403] and natural magnetic variation.

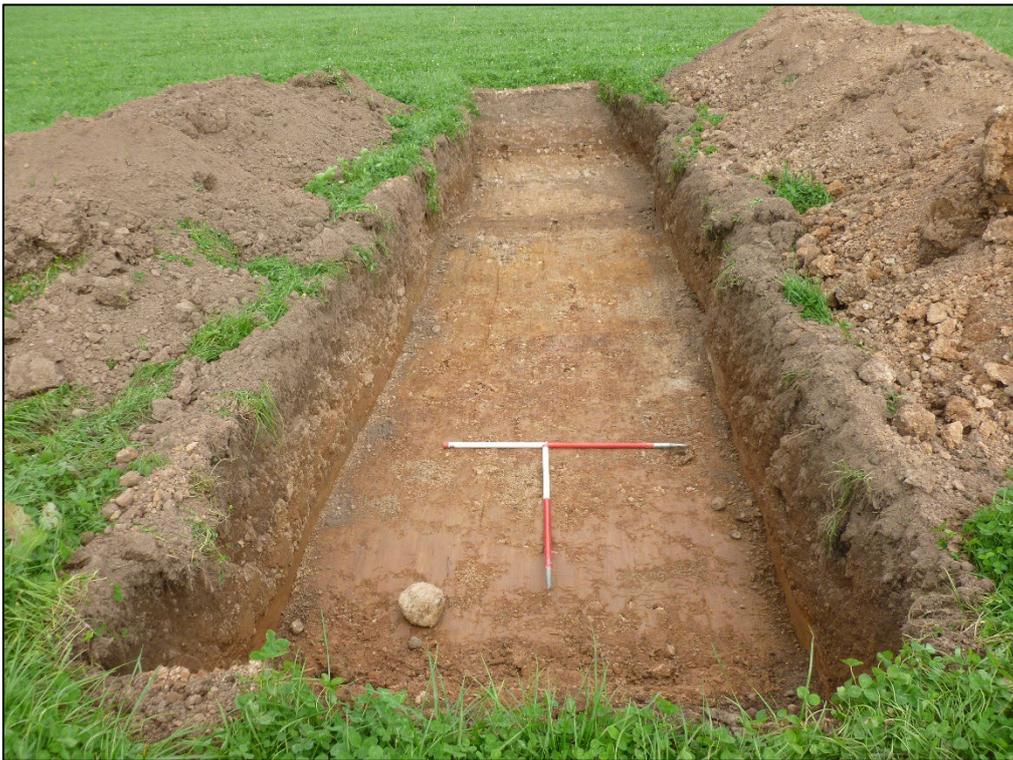
*Plate 6: Trench 4, view to the Northeast, linear [403] unexcavated. 2x1m scale.*

4.5.1 Trench 4 measured 10m long by 1.8m wide and was excavated to a maximum depth of 0.8m. It was orientated approximately NE-SW and was located to the west of Trench 6 in order to test one of the linear magnetic responses comprising geophysical anomaly F4.

4.5.2 The basal deposit (402) was interpreted as a natural mid-reddish brown silty clay with light orangey grey and light pinkish grey sand. The deposit was encountered at a depth of 0.6m below ground level and had an exposed thickness of 0.2m. Natural layer (402) was overlaid by subsoil (401).

4.5.3 Layer (401) comprised a mid-reddish brown sandy silt subsoil containing moderate inclusions of rounded and subangular sandstone. It was encountered at a depth of 0.30m below ground level and had an exposed thickness of 0.3m. Deposit (401) was cut by linear ditch [403].
