## Archaeological Trenched Evaluation Report:

On Land North of Bronwylfa Road,  
Rhostyllen, Wrexham.

November 2023

Report No. 2241

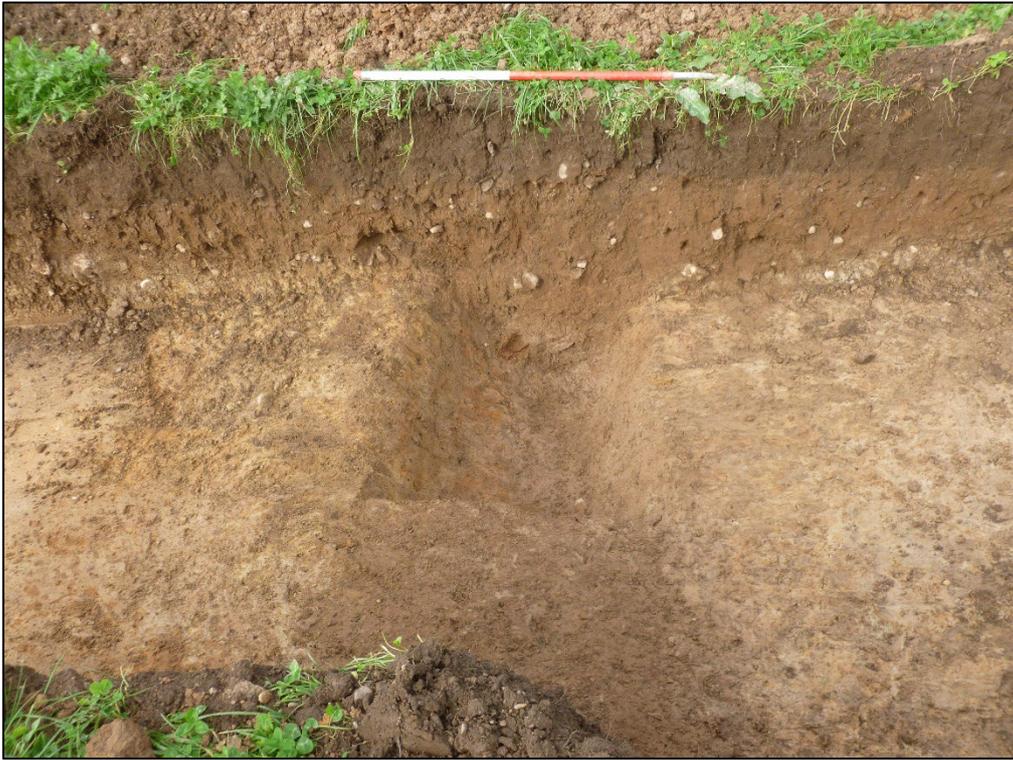
*Plate 7: East southeast facing section of ditch [403] partially excavated, view to the West northwest. 1m scale.*

4.5.4 Linear ditch [403] was located in the northern part of the trench. It was orientated E-W, with a symmetrical profile, steep sides and a concave base. It measured 1.8m long as exposed within the trench, and continued beyond the limit of excavation, a width of 1m, and a maximum depth of 0.8m. The ditch was filled by deposit (404).

4.5.5 Fill (404) comprised a firm mid-greyish brown sandy silt containing rare small to medium subangular stones. It also contained a metal (Fe) pipe of likely modern date. Fill (404) was overlain by topsoil (400). Linear ditch [403]/(404) appears to correspond with the northern arm of a possible enclosure (F4) identified during the geophysical survey. However, the fact that fill (404) contains a post medieval or modern Fe pipe, would indicate that this linear more correctly exists in isolation from any putative enclosure and potentially serves a cattle trough located inside the southern boundary of this field.

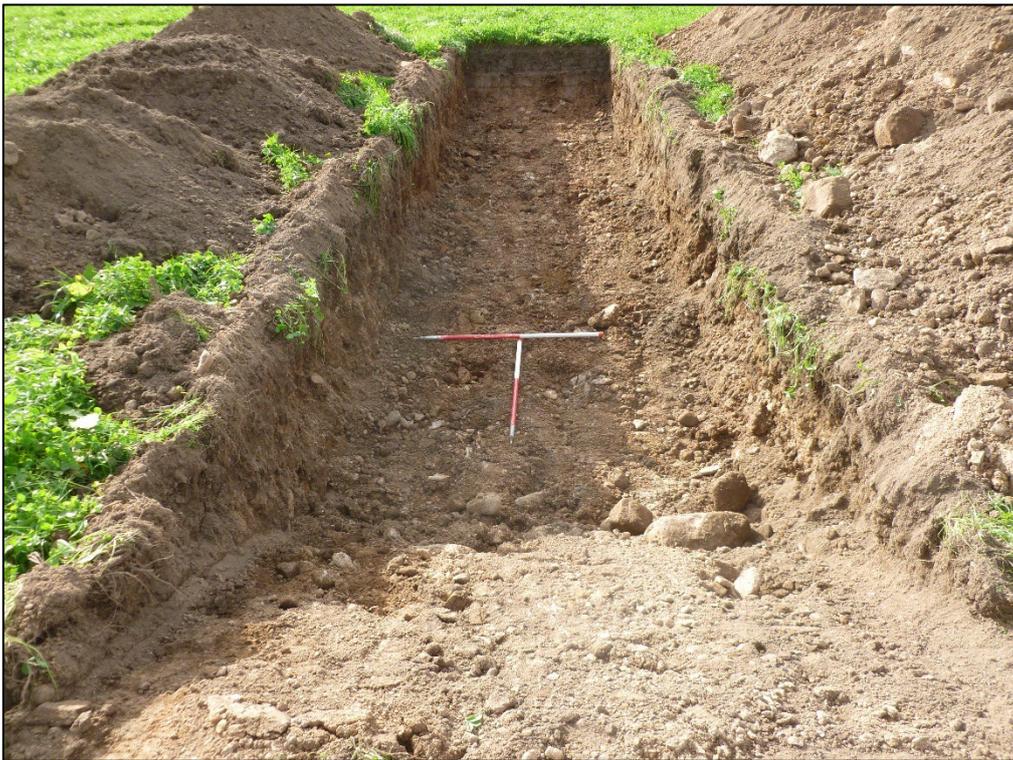
*Plate 8: Trench 5 fully excavated, view to the South southwest. 2x1m scale.*

4.6.4 Layer (500) was a mid-greyish brown sandy silt topsoil with no inclusions. The deposit had a maximum thickness of 0.4m.

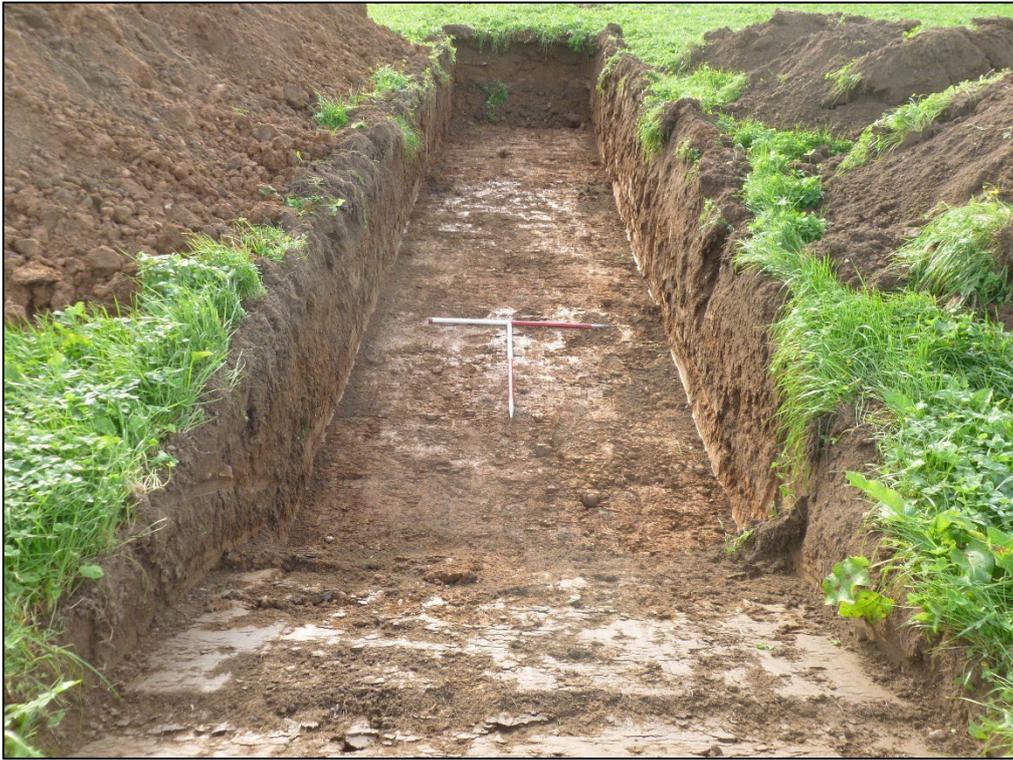
*Plate 9: Trench 6 fully excavated, view to the South southeast. 2x1m scale*

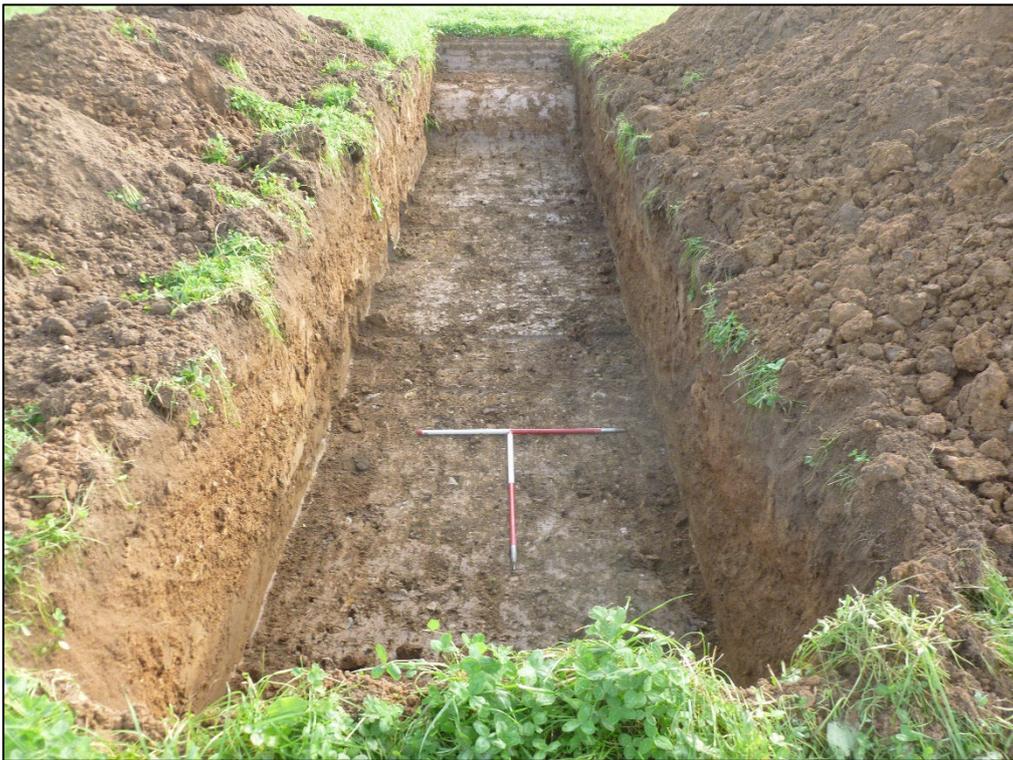
*Plate 10: Trench 7 fully excavated, view to the East. 2x1m scale.*
