# BS5837 TREE SURVEY

Arboricultural Impact Assessment, Method Statement & Tree  
Protection Plan: Land North of Bronwylfa Road.

09/11/2023  
REV: V1.1

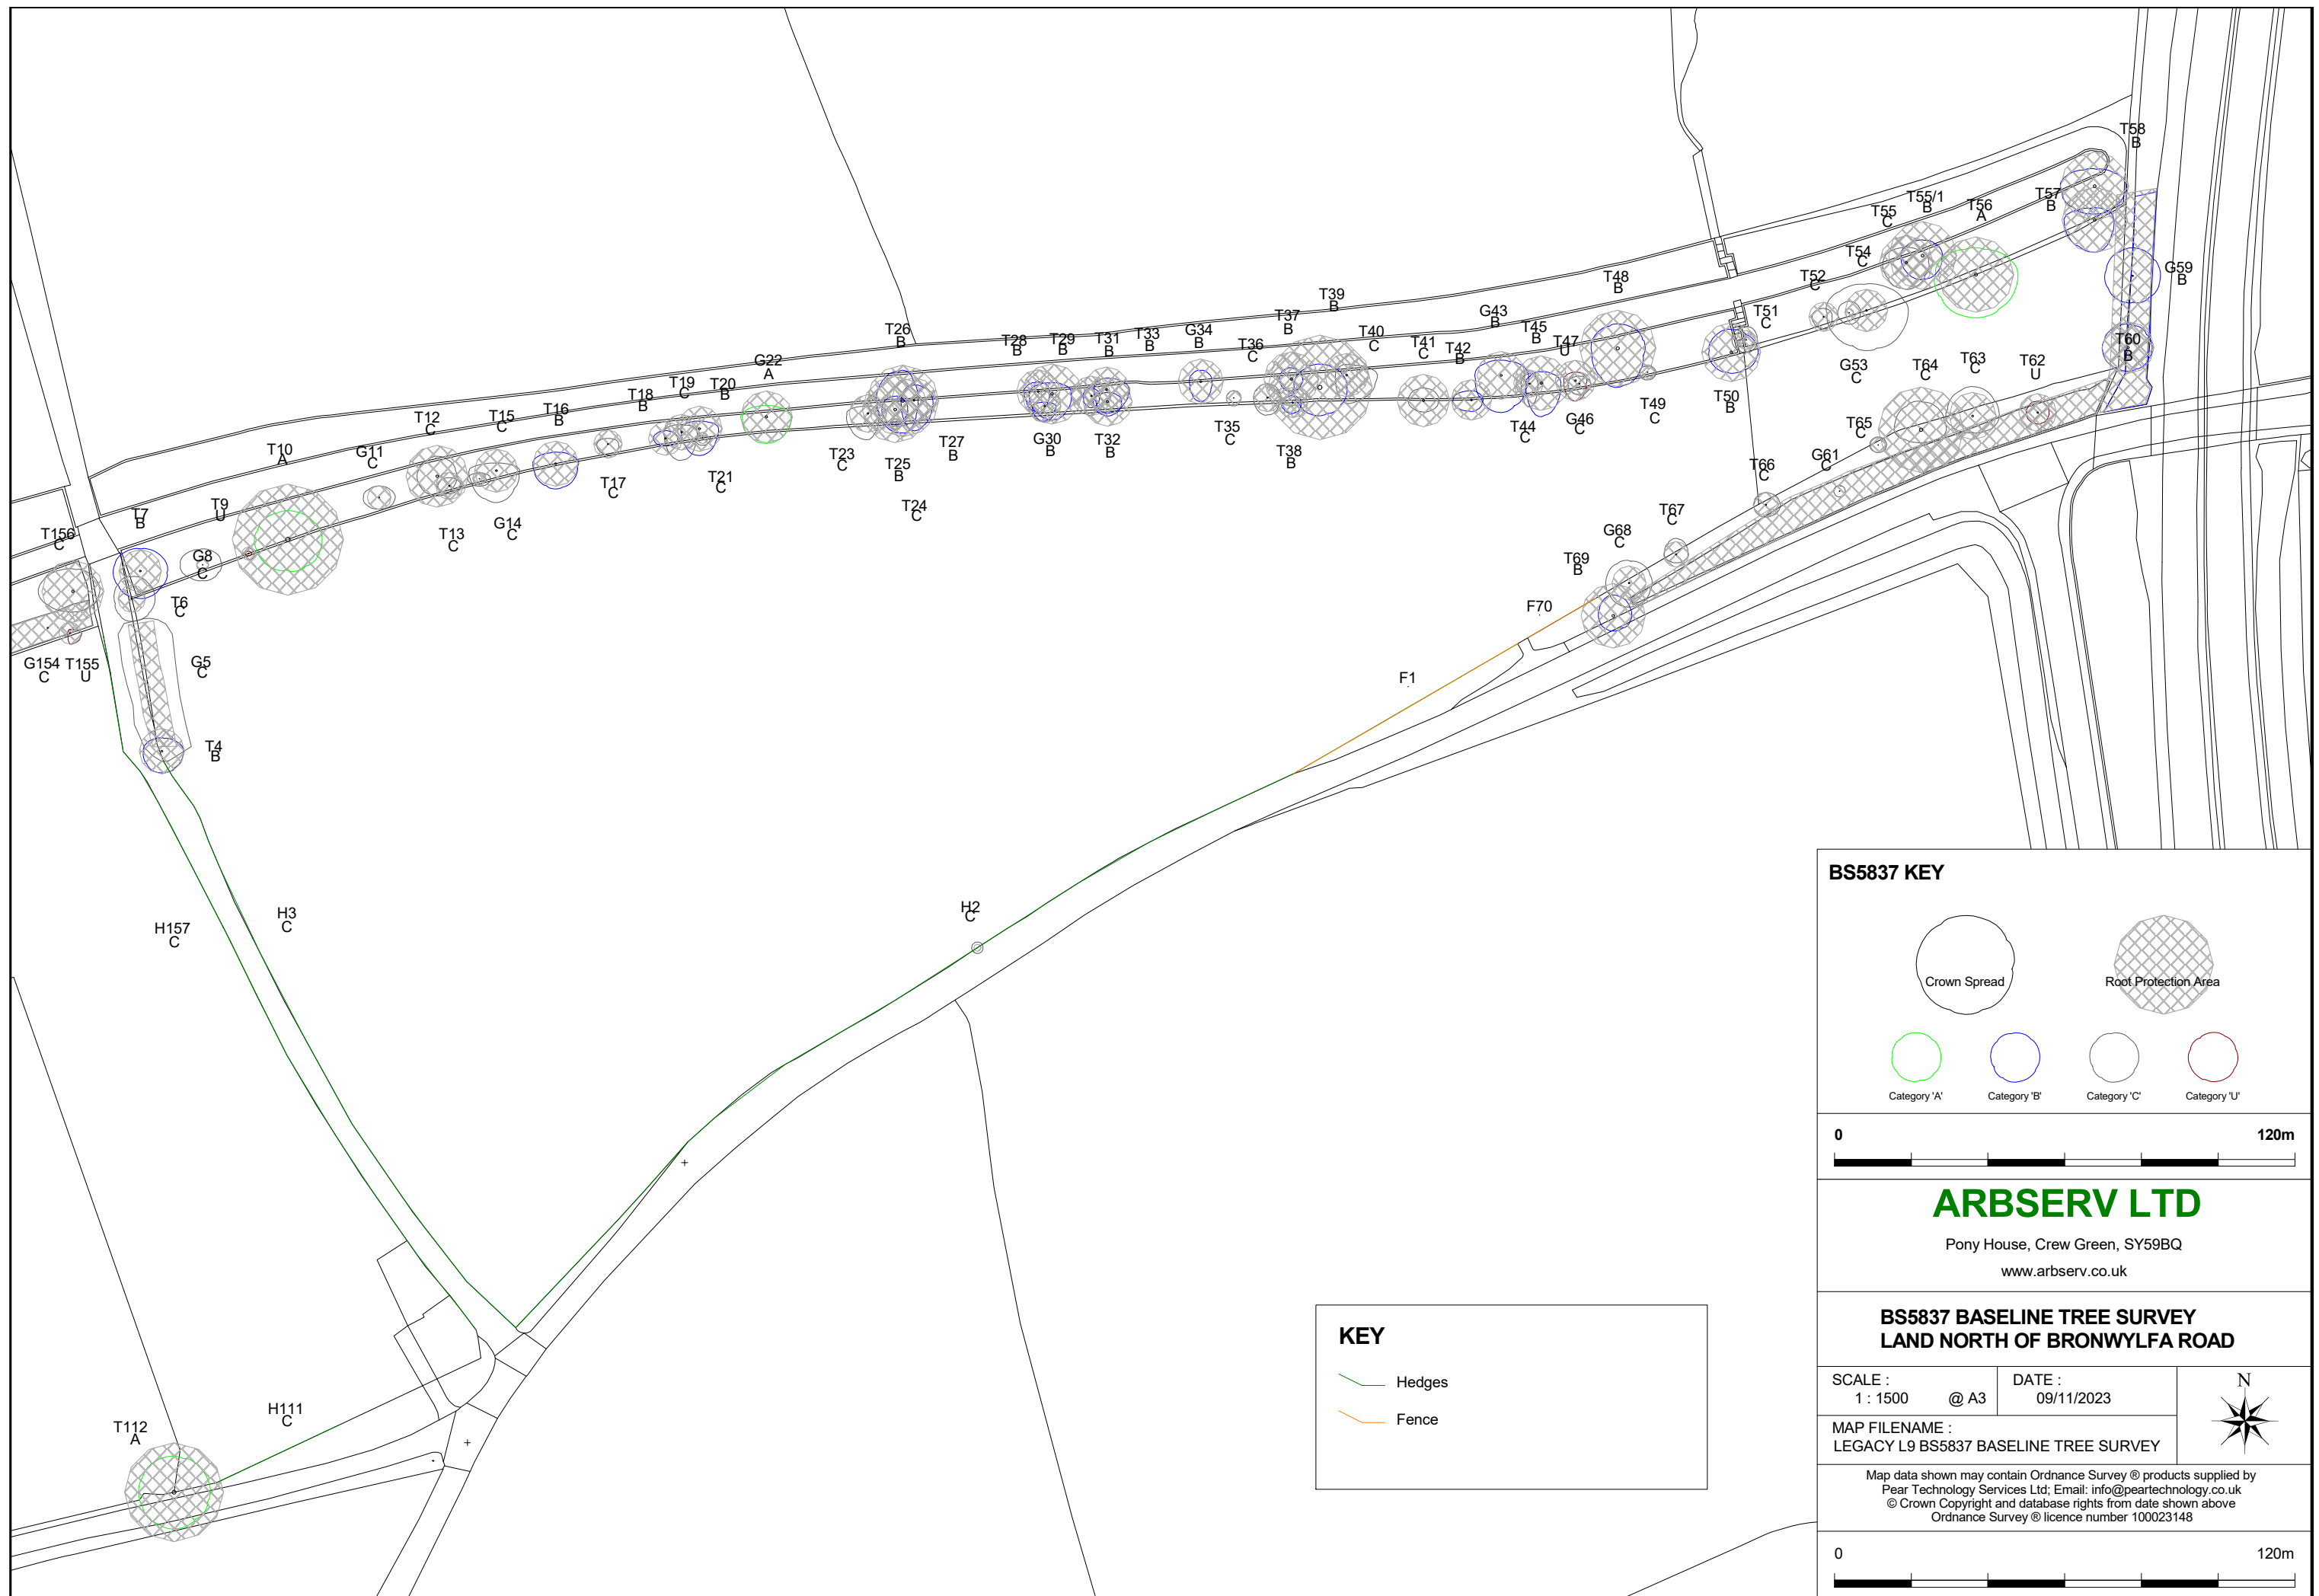
## APPENDIX 1: BS5837 TREE PROTECTION PLAN

No trees proposed for removal. The layout considered existing tree stock at the design stage to avoid Root Protection Zones. The RPA's are to be protected by CEZ Construction Exclusion Zone barriers as shown (lilac).

'Hedgerow Enhancement Planting' around the site will mitigate the proposed hedge removal. The current wooden post and rail fence F1 and F70 (orange) will be planted up and this accounts for 41.5m alone to mitigate the 54m proposed for removal. With an additional 56m of hedgerow replanting on the South boundary below the attenuation basin.

Overall, the main Arboricultural Method Statement of this scheme is to retain trees and protect them with a CEZ fence as shown on the plans. This will afford protection for the trees and their rooting environment.

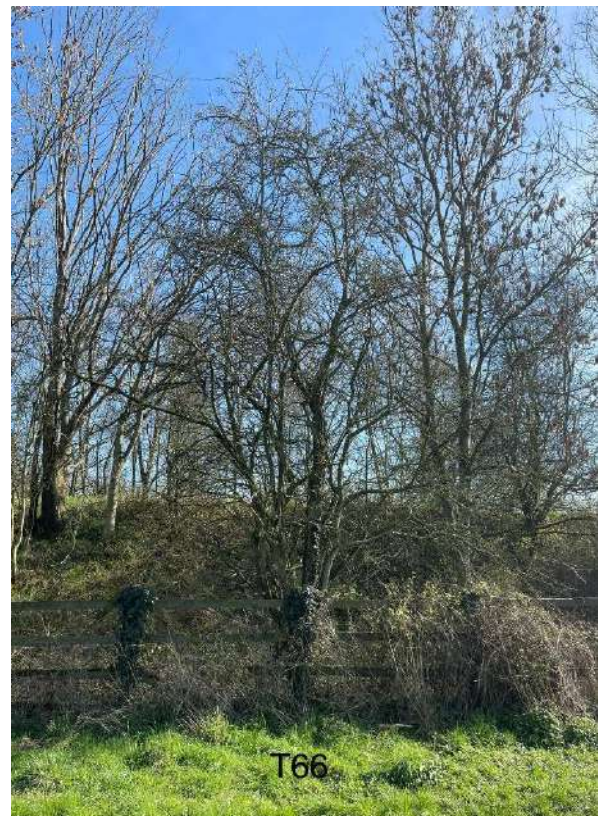
Tree and Tag No Species		Hght (m)	Stems		Crown		Age	RP A (m²) R (m)	Phys Condition	Structural Condition	Preliminary Recommendations			Cat ERC
			No	Ø (mm)	Spread (m)	Clear (m)					Survey Comment			
T66											Estimated Measurements			
Common Hawthorn <i>Crataegus monogyna</i>		6.8	1	270	N	3.2	M	A: 33 R: 3.24	Good	C: Good S: Good B: Good	ARBORICULTURAL IMPACT ASSESSMENT: The proposed build falls out-side the RPA. METHOD STATEMENT: Install the section of Haras fence barrier positioned as indicated on the tree protection plan to create the CEZ.			C >40 yrs
T67											Estimated Measurements			
Common Ash <i>Fraxinus excelsior</i>		8.7	1	270	N	4.2	SM	A: 33 R: 3.24	Poor	C: Poor S: Fair B: Good	ARBORICULTURAL IMPACT ASSESSMENT: The proposed build falls out-side the RPA. METHOD STATEMENT: Install the section of Haras fence barrier positioned as indicated on the tree protection plan to create the CEZ. NOTE: Semi mature Ash, early signs of ADB.			C <10 yrs

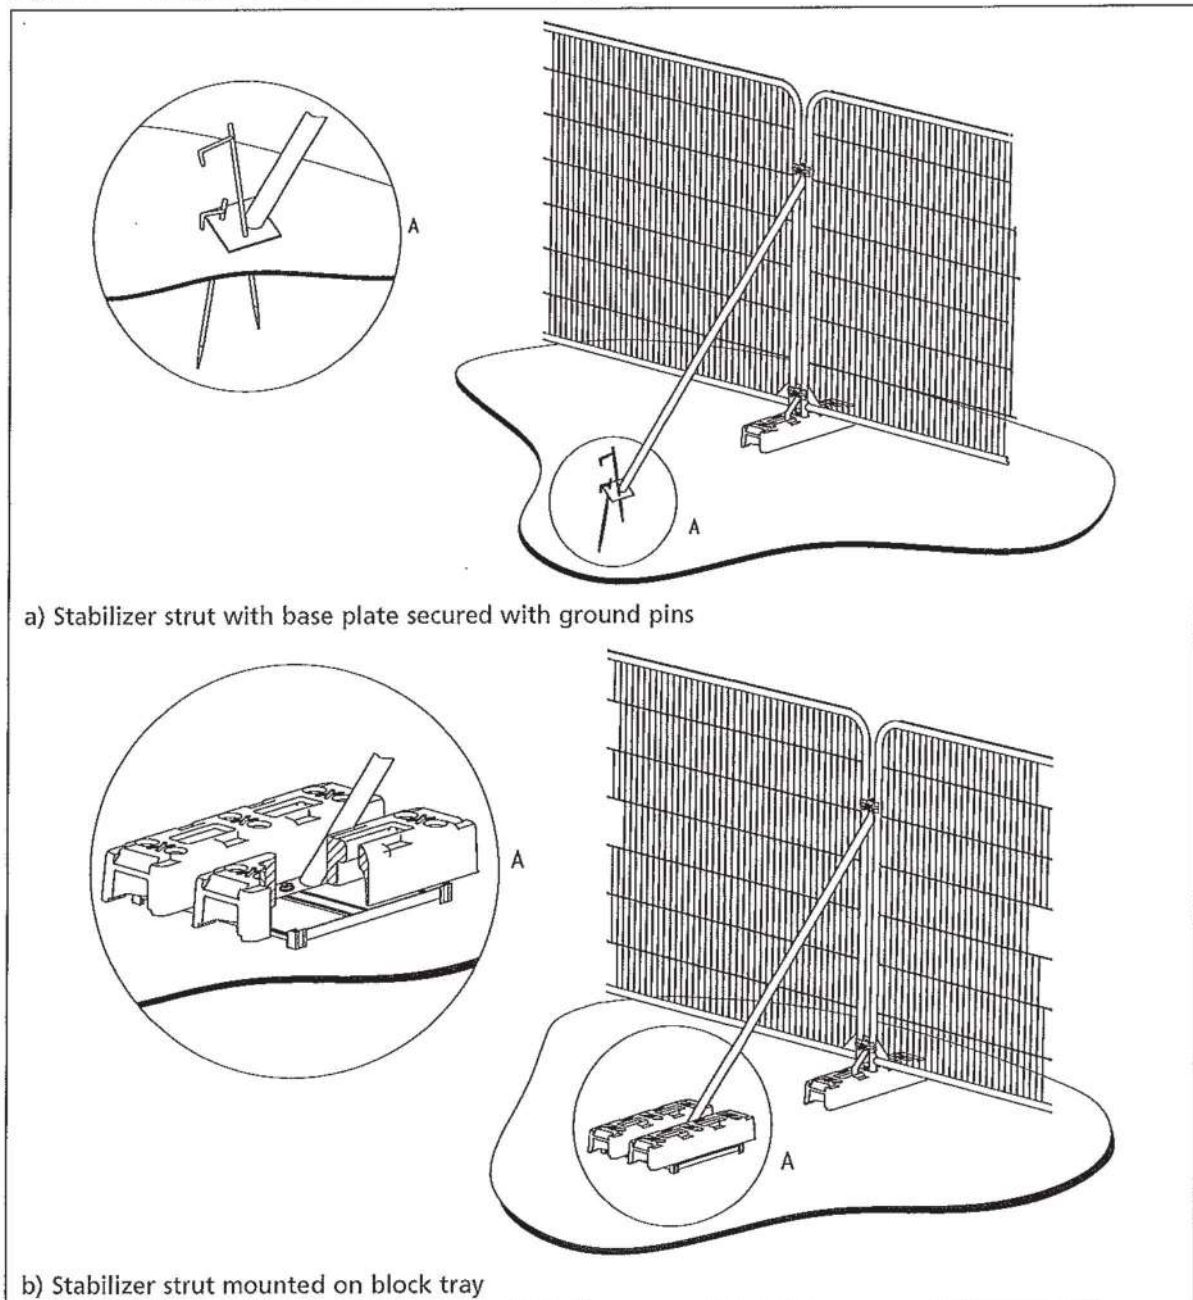
Figure 3 Examples of above-ground stabilizing systems

**6.2.2.3** Where the site circumstances and associated risk of damaging incursion into the RPA do not necessitate the default level of protection, an alternative specification should be prepared by the project arboriculturist and, where relevant, agreed with the local planning authority. For example, 2 m tall welded mesh panels on rubber or concrete feet might provide an adequate level of protection from cars, vans, pedestrians and manually operated plant. In such cases, the fence panels should be joined together using a minimum of two anti-tamper couplers, installed so that they can only be removed from inside the fence. The distance between the fence couplers should be at least 1 m and should be uniform throughout the fence. The panels should be supported on the inner side by stabilizer struts, which should normally be attached to a base plate secured with ground pins (Figure 3a). Where the fencing is to be erected
