PROPOSED CABLE ROUTE Cefn Park and Wrexham PV

Ecological Appraisal

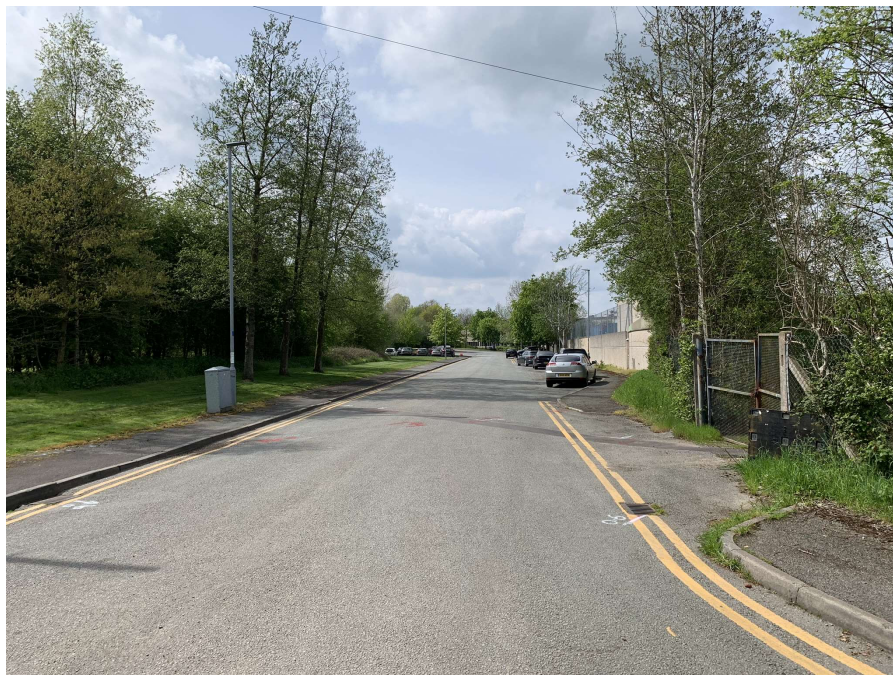
Along Bedwell Link the proposed cable route runs within the existing carriageway comprising of hardstanding. Semi-improved neutral grassland and semi-natural broadleaved woodland are present just outside of the redline boundary, with scattered broadleaved trees also present including horse chestnut (*Aesculus hippocastanum*), mountain ash (*Sorbus aucuparia*), whitebeam (*Sorbus aria*) and field maple (*Acer campestre*).

Photograph 1; Bedwell Link

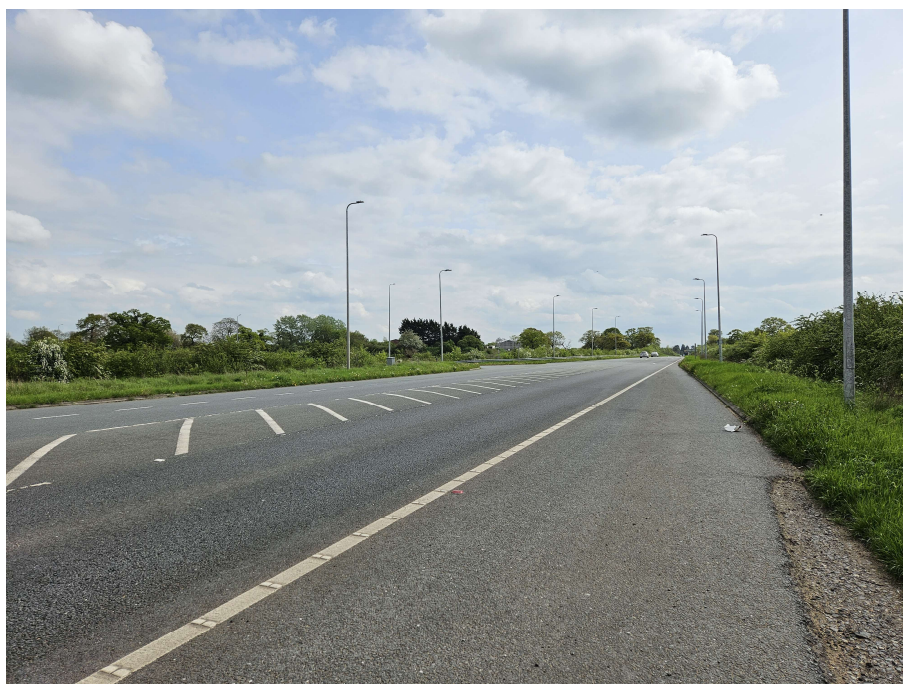
Photograph 2; Sesswick Way

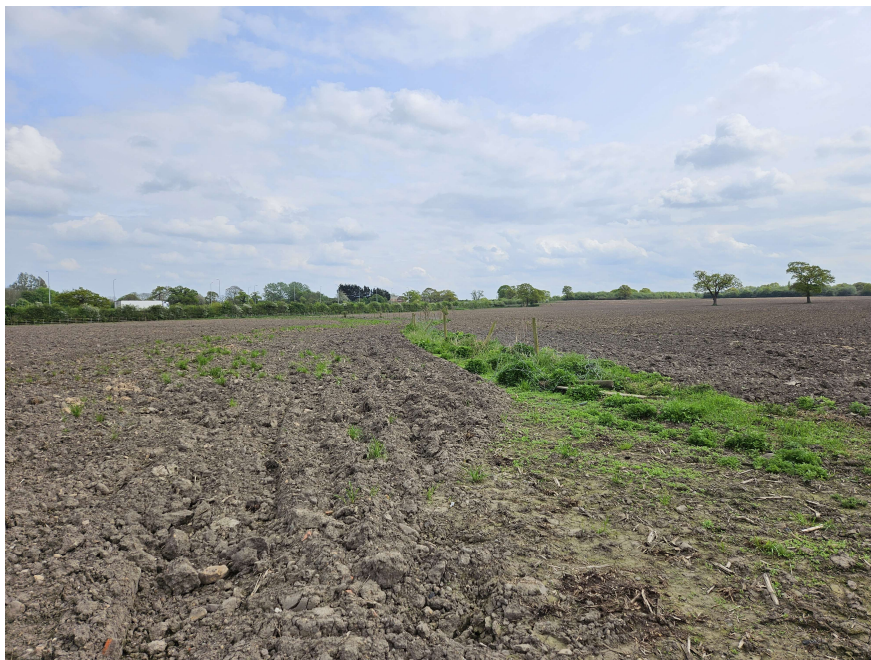
To the west of Sesswick Way the proposed cable corridor comprises arable farmland which had been recently ploughed at the time of survey. A stock-proof fence runs along the southern edge of the red line boundary. A single mature oak tree (*Quercus robur*) is located adjacent to the south of the red line boundary near to the new substation.

Photograph 3; arable field west of Sesswick Way

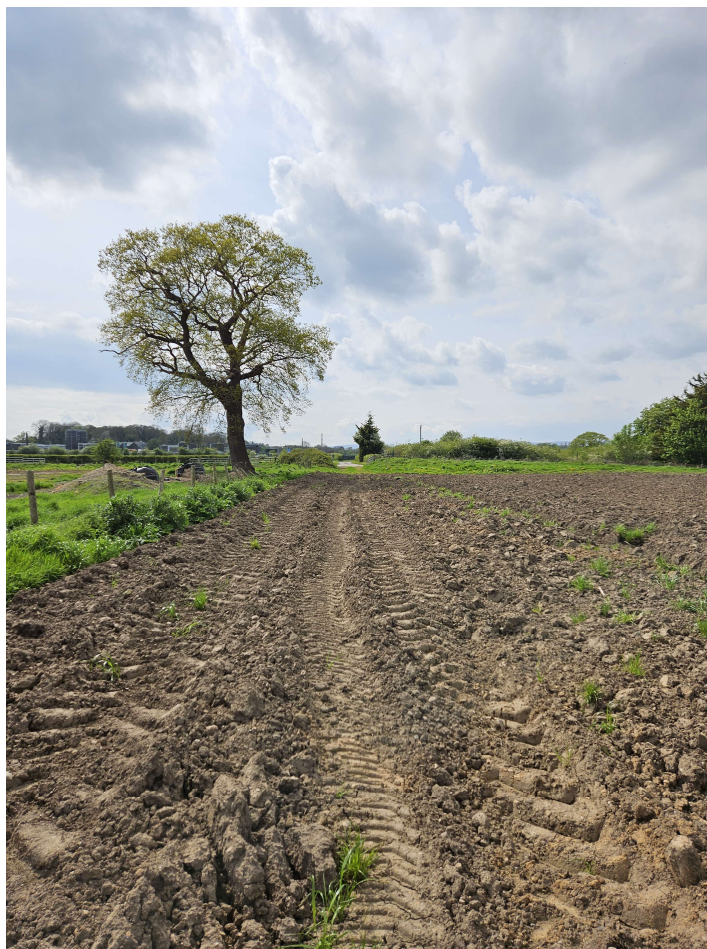
Photograph 4; mature oak adjacent to the south of the route

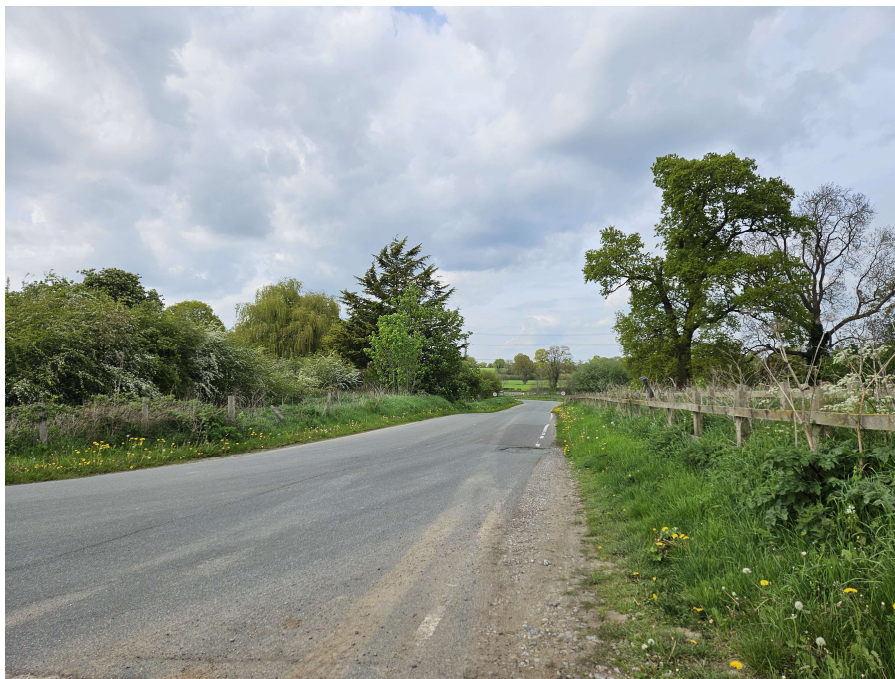
The route runs through further arable land northwards towards the Afon Clywedog. There is a line of mature broadleaved trees through which the route passes, including oak and ash, with ivy coverage. The riparian zone of the Afon Clywedog comprises semi-mature willow and scattered Himalayan balsam.

Photograph 5; looking north towards Cefn Road with mature trees on the right.

The mature broadleaved trees within the arable land to the east of the substation offer a number of Potential Roosting Features (PRF) such as cracked and failed limbs, knot holes and occasional woodpecker or rot holes of Low Bat Roost Potential. The trees also provide suitable habitat for nesting birds.

supervision to ensure there is no disturbance posed to the bat roost. Further measures such as the restriction of reversing beeps and a 10m exclusion zone for all vehicles.

- Any vegetation requiring removal prior to the start of works must be subject to a nesting bird survey if removal is planned during the nesting bird season (March to August inclusive).
- The Afon Clywedog and its riparian zone must not be subject to any direct impacts. It is therefore recommended that installation of the cable be via directional drill techniques. No construction/installation activities are to encroach within 5m of either bank of the water-course, to further protect the riparian zone habitat.
- To prevent the spread of Himalayan balsam, no earth or spoil will be removed from site. Furthermore, by avoiding the riparian zone of the Afon Clywedog, the risk of encountering Himalayan balsam is significantly reduced.

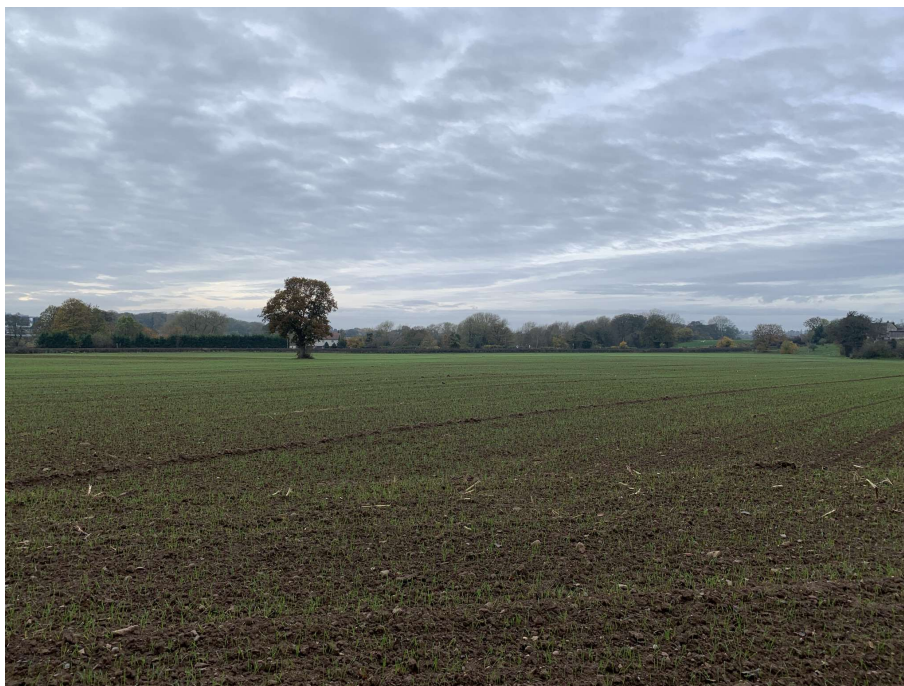
To the north of Cefn Road and the Afon Clywedog, there is a species-poor hedgerow along the roadside and further arable land beyond through which the cable corridor runs to connect to the new solar farm.

Photograph 6; arable land at Cefn solar farm
